Service and Parts Operations

RPB#02-107

SUBJECT: 01073A - STOP LAMPS/HAZARD LAMPS INOPERATIVE

PRODUCT SAFETY BULLETIN #01073A - JULY 29, 2002

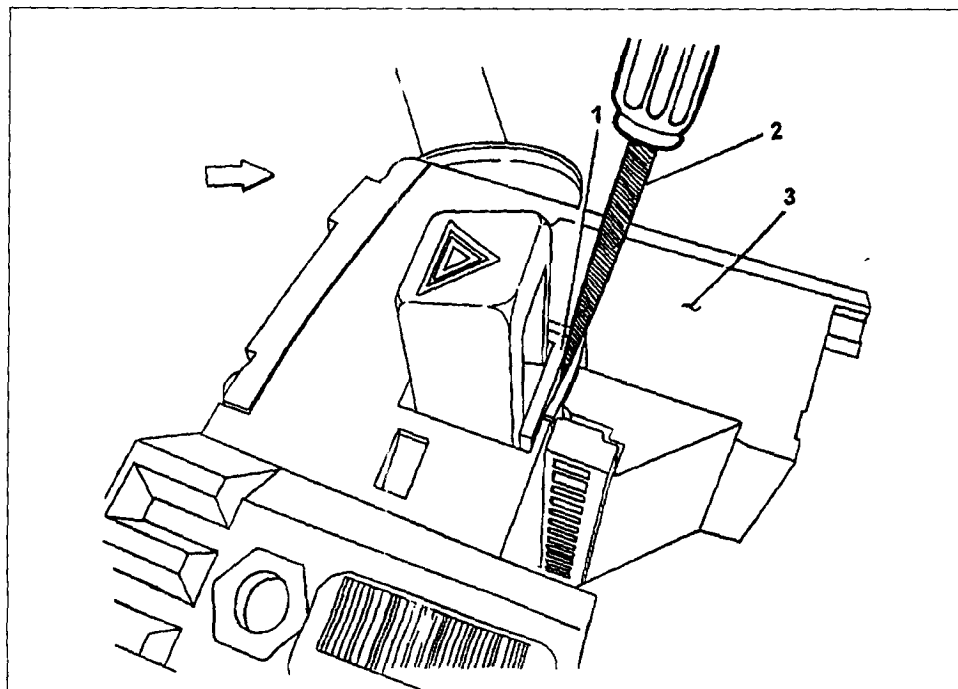
856061

12. Inspect the part number (1) on the multifunction switch at the location shown in the illustration.

- If the part number is 26100837 or 26100838, no repair is required. Proceed to the section titled "Reassemble Vehicle."
- If there is NO part number or barcode on the switch, or if the part number is 26083635 or 26083636, proceed to the next step and replace the hazard warning flasher switch.
- If the part number or barcode on the switch is 26090641, 26090642, 26096832, or 26096833, replacement of the multifunction switch is required. Proceed to the section titled "Replacing the Multifunction Switch."
