Service Bulletin

4 - STROKE
GS/GSX/GSX-R BULLETIN NO. 183
DATE: 6/6/2008

**SAFETY RECALL CAMPAIGN #2A05
CERTAIN 2008 GSX1300RK8 MOTORCYCLES
IGNITION SWITCH INSPECTION/REPLACEMENT**

AFFECTED UNITS: CERTAIN 2008 GSX1300RK8 MOTORCYCLES

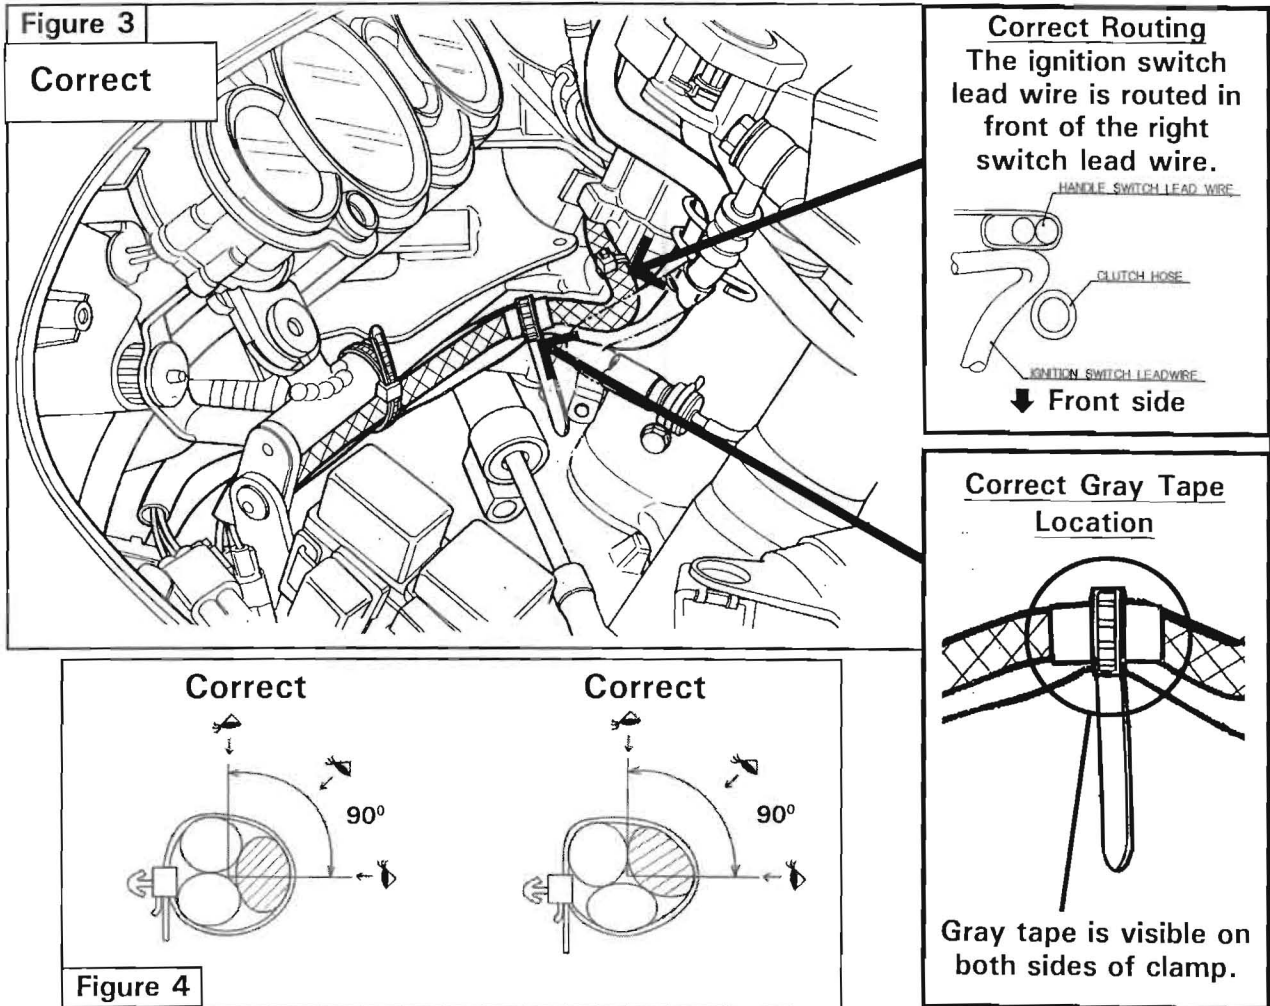
1. Remove the upper and lower meter panels (refer to Service Manual page 9D-15).
2. Check if the ignition switch lead wire is clamped and routed correctly. Incorrect positions are shown in Figures 1 and 2. Correct routing and clamping is shown in Figures 3 and 4 on page 5.

1. Reroute the ignition switch lead wire correctly (Figure 3 and Figure 4). The ignition switch lead wire should not be covered by the other wire harnesses.
2. Turn the handlebars back and forth to verify that the steering operates smoothly and the wiring harness does not become kinked or pinched.
3. Proceed to PUNCH MARK AT VIN on page 8.
