DATE: August 25, 2008
TO: Mitsubishi Motors Service Managers
RE: SR-08-004 – Galant Shift Interlock Safety Recall
ATIN NO. ATIN-08-SR-004

AFFECTED VEHICLES: 2004-05 Galant

SUBJECT:		No: SR-08-004	
GALANT SHIFT INTERLOCK SAFETY RECALL CAMPAIGN		DATE: August, 2008	
		MODEL: 2004-05 Galant	
CIRCULATE TO:	<input type="checkbox"/> GENERAL MANAGER	<input checked="" type="checkbox"/> PARTS MANAGER	<input checked="" type="checkbox"/> TECHNICIAN
<input checked="" type="checkbox"/> SERVICE ADVISOR	<input checked="" type="checkbox"/> SERVICE MANAGER	<input checked="" type="checkbox"/> WARRANTY PROCESSOR	<input checked="" type="checkbox"/> SALES MANAGER

On some affected vehicles, it may be possible for the key to be removed from the ignition switch when the transmission gear selector is in a position other than P (Park). The gearshift to ignition switch interlock system may allow the ignition key to be removed from the ignition switch without placing the gearshift in the "P" position. If the driver does not shift to "P" before removing the key from the ignition, and does not engage the parking brake, the vehicle could roll away and a crash could occur.

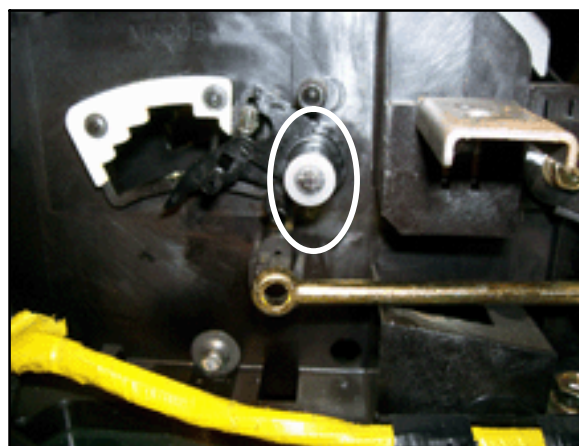
Either of the tangs for the split post could be broken. Broken tangs can occur during lock cam rod installation. Take care when installing the lock cam rod onto this post and inspect it after installation.

1. Place the shift lever in the "P" position and the key in the "LOCK" position.
2. Carefully remove the rod from the selector lever lock cam. **!!!CAUTION!!! Take care to not break the tangs of the selector lever lock cam post.**
3. CAREFULLY remove the lock cam retaining washer using a small screwdriver and needle nosed pliers. **!!!CAUTION!!! Take care when removing the retaining washer. If the lock cam mounting post is broken, the shifter assembly must be replaced.**

SUGGESTION: Using needle nosed pliers, squeeze the washer while pulling gently towards you. This will fold it and weaken the metal. Use diagonal cutters to twist the washer and work it off by carefully turning the washer like a nut and pulling at the same time.

4. Slightly depress the release button on the top of the shift lever to rotate the lock cam. Remove the lock cam.
5. Install the new lock cam onto the shift lever assembly.
6. Install the new lock cam retaining washer and confirm that it is secure.
