Subject: Revision to Recall Campaign 08V-397 (37D5/J2)

**Subject: Revision to Safety Recall Circular 37D5/J2
1996-2003 Audi A8 with 5-speed Automatic Transmission
Automatic Transmission Locking Cable Modification**

Code: 37D5/J2

Subject: 1996-2003 Audi A8 with 5-speed Automatic Transmission
Automatic Transmission Locking Cable Modification

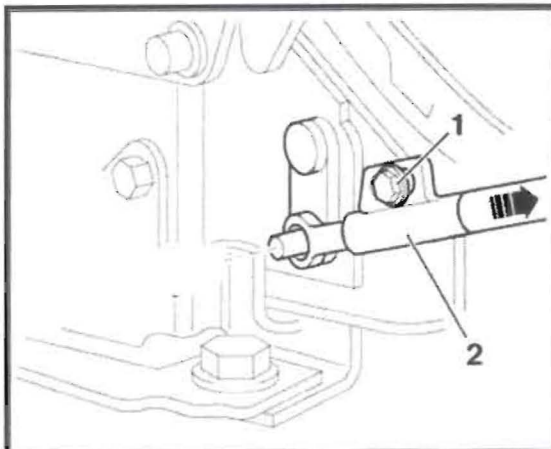
Tip: Elongated hole –arrow- will no longer be used for locking cable adjustment

⇐ Disengage locking cable -2-

Tip: One of four adjusting pieces (part number 4D0713299 B, C, D, or E) with different hole alignments will now be used instead of elongated hole.

To determine the correct adjusting piece, try each one until the best fitting piece is matched
