# MEDIC UPDATE

## SAFETY RECALL BULLETIN

<b>SUBJECT:</b> <b>FUEL TANK BRACKET SAFETY RECALL</b>		No: <b>SR-08-005</b>	
		DATE: <b>September, 2008</b>	
		MODEL: <b>See Below</b>	
<b>CIRCULATE TO:</b>	<input type="checkbox"/> GENERAL MANAGER	<input checked="" type="checkbox"/> PARTS MANAGER	<input checked="" type="checkbox"/> TECHNICIAN
<input checked="" type="checkbox"/> SERVICE ADVISOR	<input checked="" type="checkbox"/> SERVICE MANAGER	<input checked="" type="checkbox"/> WARRANTY PROCESSOR	<input checked="" type="checkbox"/> SALES MANAGER

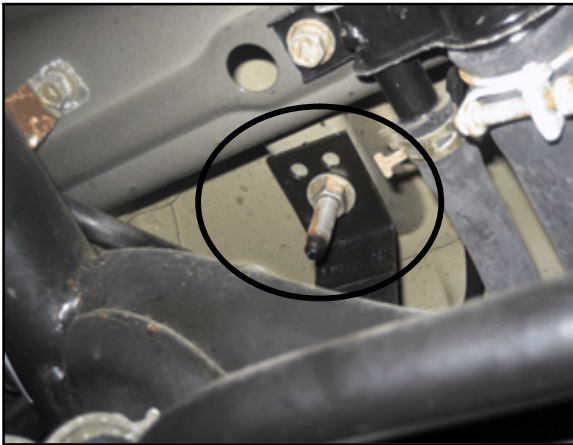
2. Locate the front and rear mounting brackets for the left (driver's) side fuel tank strap. (This illustration shows the rear of the left fuel tank strap, secured with a nut over the bracket and stud assembly.)
