ITB08-045e

December 2, 2015

## VOLUNTARY RECALL CAMPAIGN 2007 – 2008 PASSENGER AIR BAG OCCUPANT CLASSIFICATION SYSTEM (OCS)

CAMPAIGN ID #: P8243  
NHTSA #: 08-521  
APPLIED VEHICLES: 2007 – 2008 G35 Sedan (V36)  
2008 G37 Coupe (V36)  
2008 EX35 (J50)

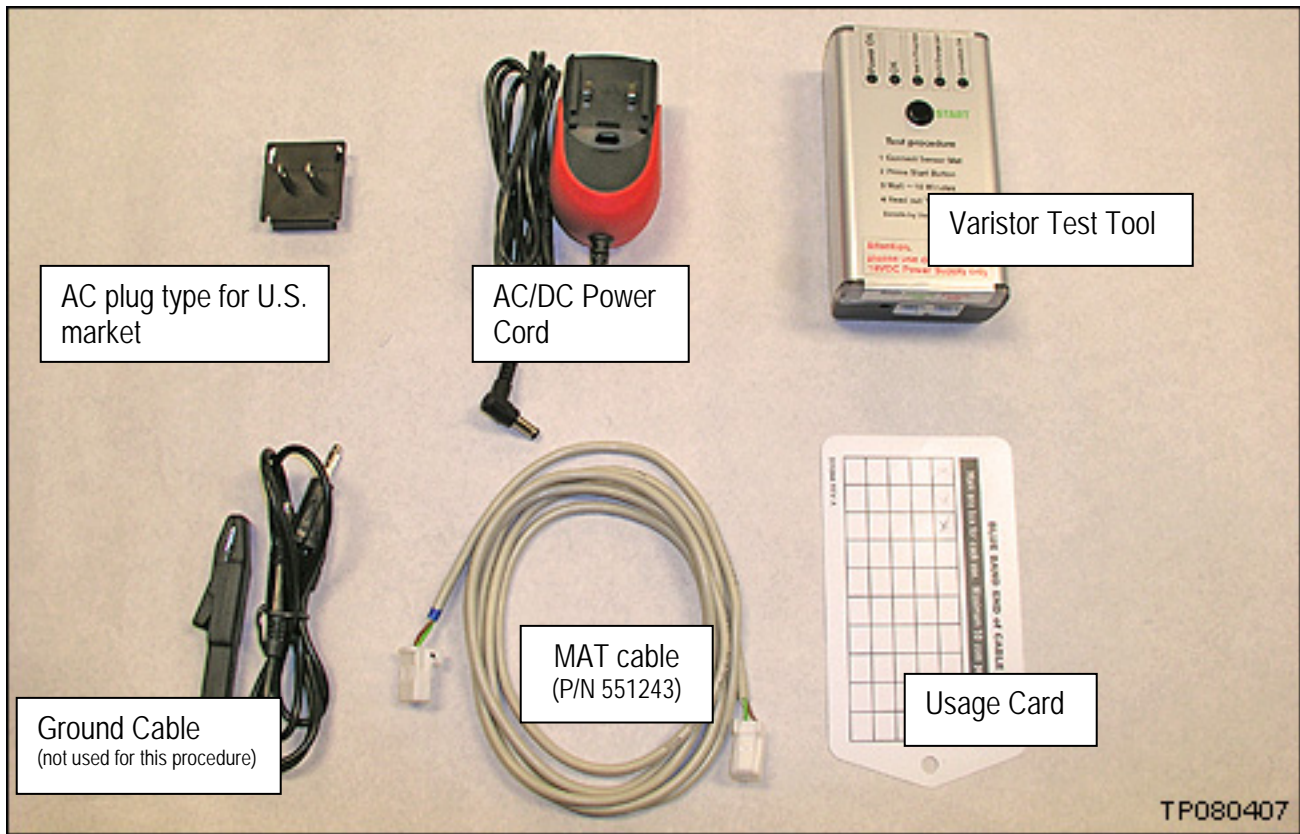
Figure A

### OCS Varistor Check Tool Kit – J-49787

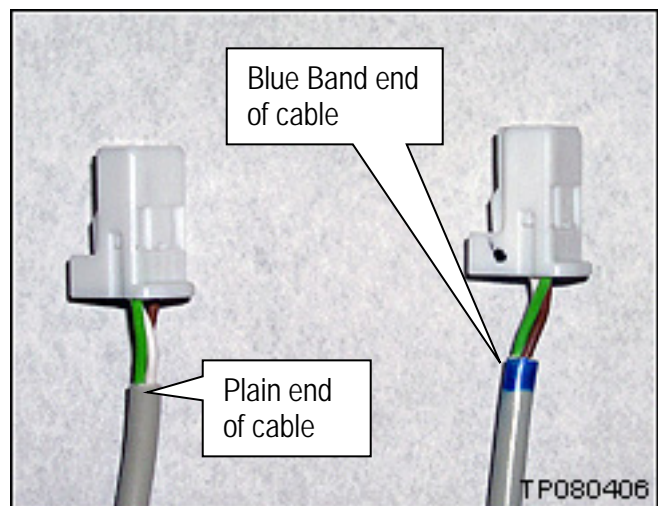
Figure B

The MAT cable ends have identifying marks which allow the user to keep track of how many times each end has been used.

- One end of the cable is marked with a "Blue Band" as shown.
- One end is "Plain" as shown.

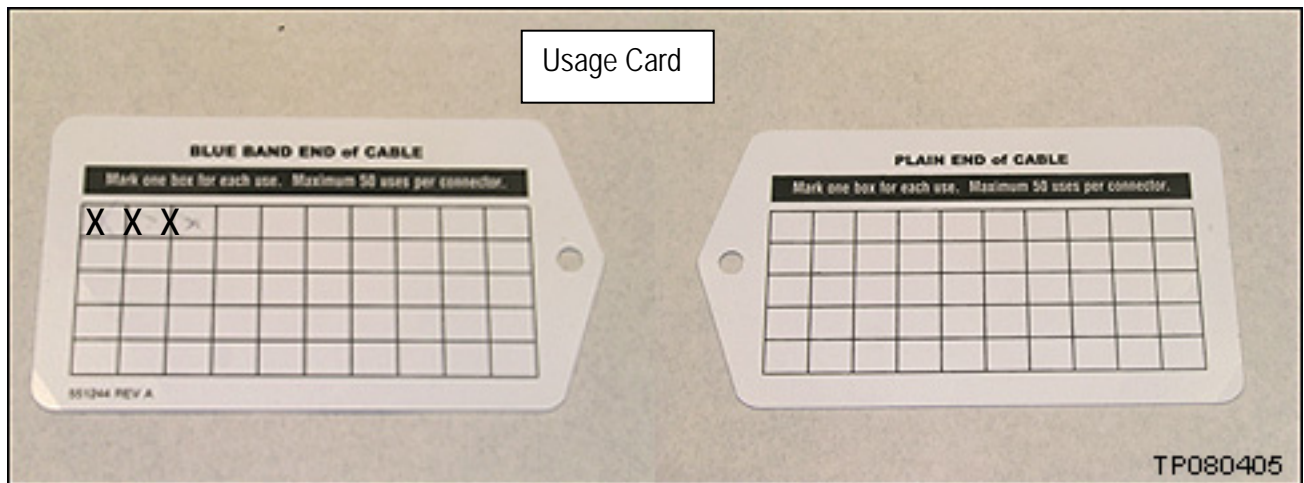
Figure C

A "Usage Card" is included with each tool kit and with each replacement MAT cable.

- One side of the card has 50 squares for the Blue Band End of Cable.
- The other side of the card has 50 squares for the Plain End of Cable.

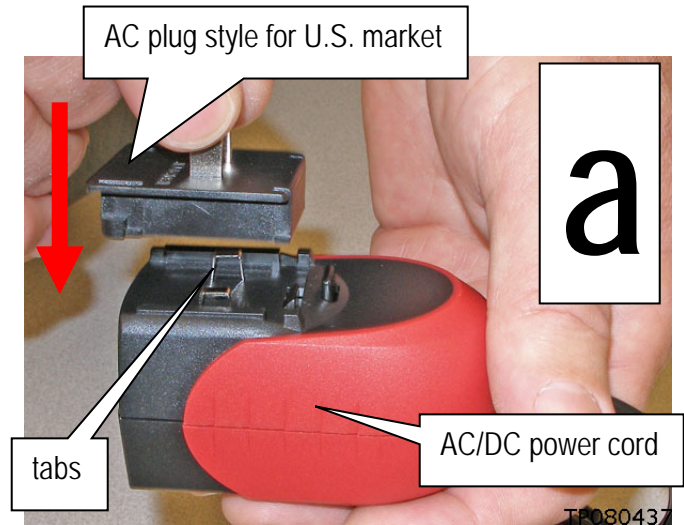
Figure E

- To install the AC plug to the AC/DC Power Cord:
  - a. Set the plug straight down onto the Power Cord tabs. (see Figure E)

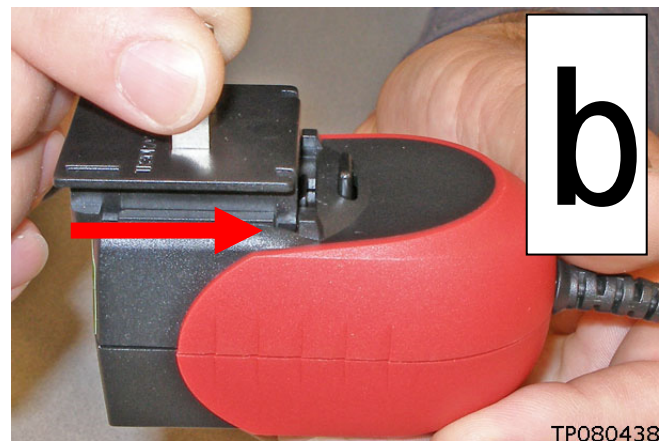
Figure F

- b. Once the adapter is on the tabs, slide the adapter on to lock it in place. (see Figure F)

**DO NOT TRY TO SLIDE THE ADAPTER ONTO THE POWER CORD TABS. THE TABS WILL BREAK IF THIS IS TRIED.**

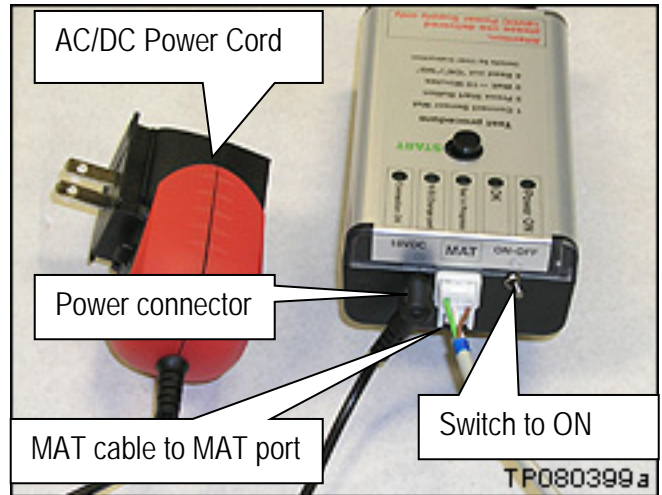
Figure H

2. Attach the AC/DC Power Cord and one end of MAT cable, and then turn on the Varistor Test Tool.
  - One end of MAT cable should be plugged into the MAT port.

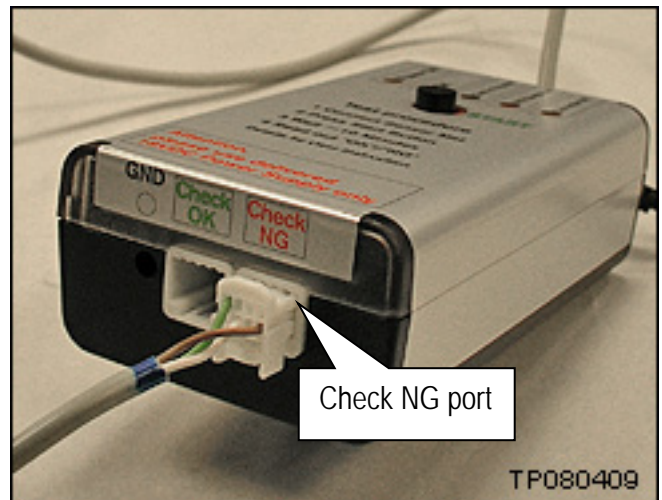
Figure I

3. Connect the other end of the MAT cable to the "Check NG" port as shown.

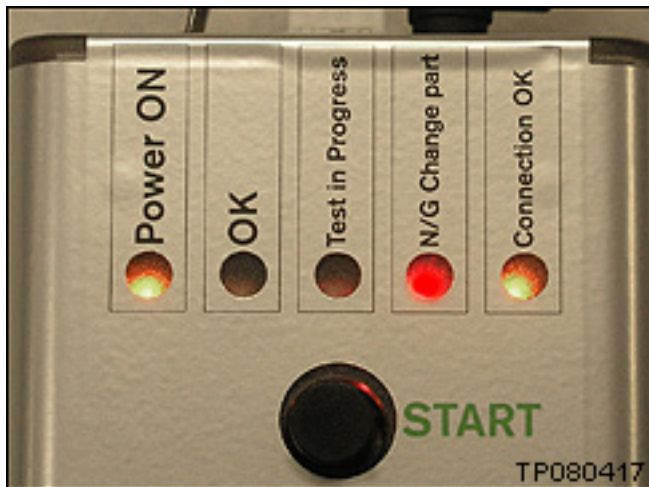
Figure J

LED ON	If LED is OFF
1	Power ON	Check power cord
2	N/G Change Part	Test tool malfunction
3	Connection OK	Check MAT cable/connection

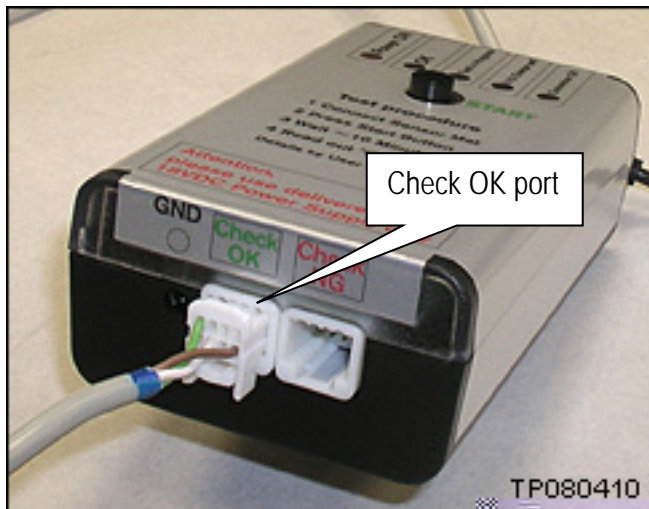
Figure K

5. Move MAT connector from “Check NG” to “Check OK” port as shown.

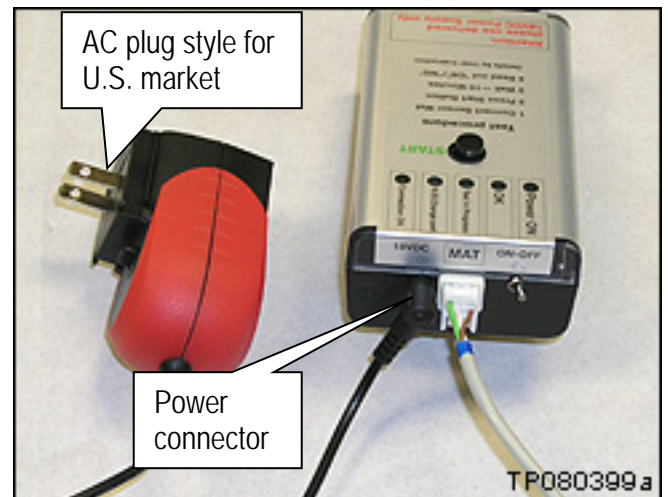
Figure 1

- The AC to 18 volt DC power cable has several plug styles to accommodate different global markets.
- Select and attach the AC plug style for the U.S. market.

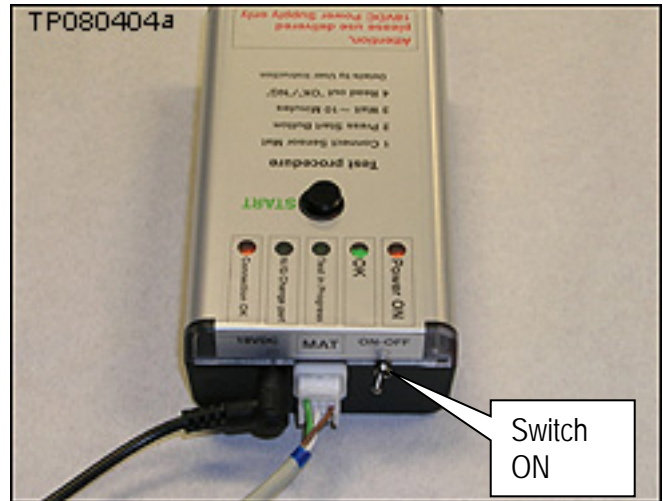
Figure 4

9. Turn ON the Varistor Test Tool.

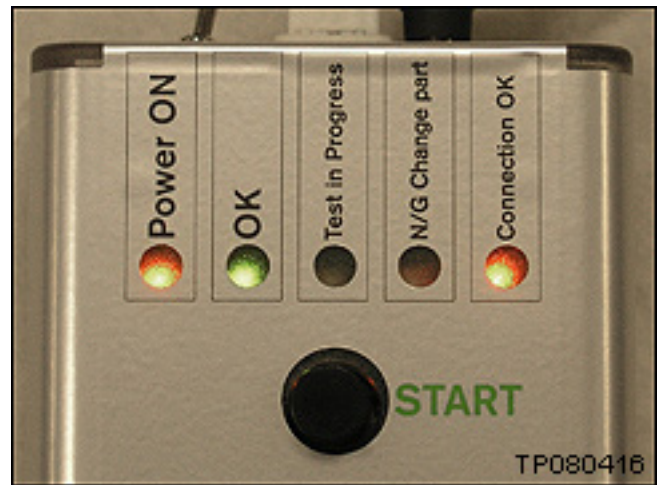
Figure 5

LED ON	If LED is OFF
1	Power ON	Check power cord
2	OK	Check MAT cable/connections
3	Connection OK	Check MAT cable/connection

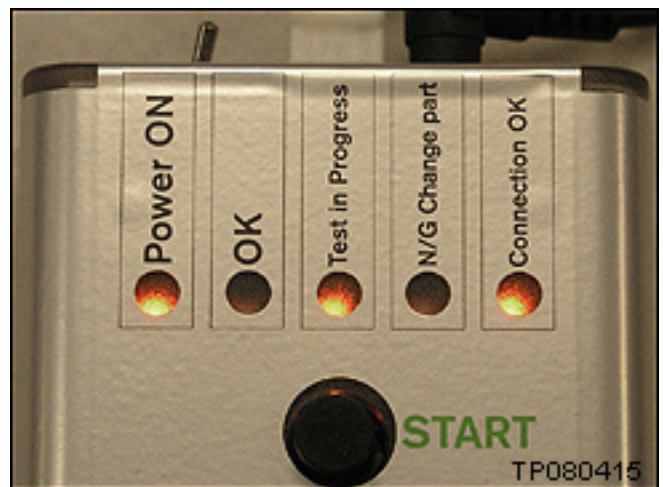
Figure 6

LED ON	If LED is OFF
1	Power ON	Check power cord
2	Test in progress	Test Tool malfunction
3	Connection OK	Check MAT cable/connection

NOTE: "OK" LED should be OFF.
