PRODUCT CAMPAIGN BULLETIN

APPLICABILITY: 2008~09MY Tribeca
SUBJECT: VDC G Sensor

NUMBER: WVG-17
DATE: Dec. 2008

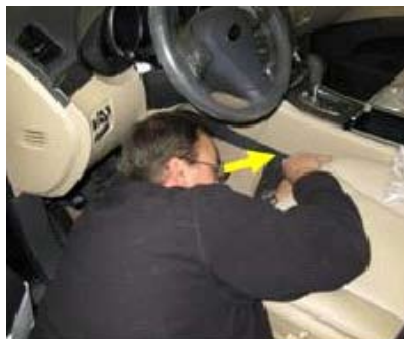
Move the driver's seat to the most reward position. Position yourself as illustrated.

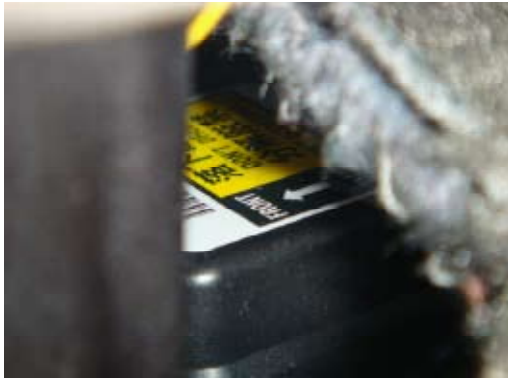
Push in, slightly pull down, and move the carpet slightly forward to gain a view of the G sensor. Use a flashlight to verify the direction of the arrow on the G sensor.

If the arrow is pointing towards the front of the vehicle, no further action is required.

If the G sensor arrow is pointing towards the rear of the vehicle, continue with the following procedure.
