**09V-091
(13 Pages)**

Battery Isolator Installation

Date: March 6, 2009

Applies to: All C5500, W-5, and F-650 Company Stores built before March 6, 2009.

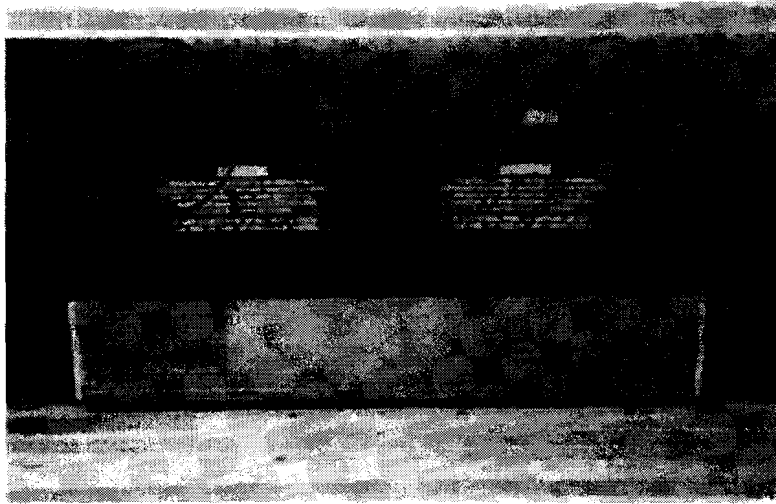
1. Turn off all DC loads at the power distribution panel
2. Remove the carpeted battery access panel to expose the auxiliary batteries.
 - a. On a W5 model, this panel is located on the driver's side of the load space below the second set of shelves.
 - b. On C5500 and F-650 models this is located on the passenger's side below the first set of shelves. The panel is attached with hook-and-loop (commonly known as Velcro™).
3. Disconnect the negative battery cable from the Auxiliary batteries. The negative battery cable will be located on the left side of the batteries toward the wall (see photo). The negative cable will be marked with black shrink tube (positive battery cables are marked with white).
