BLUE BIRD

**R09PB**

**SUBJECT: RECALL R09PB BATTERY POWER CABLE ROUTING**

# Battery Cable Routing **RECALL**

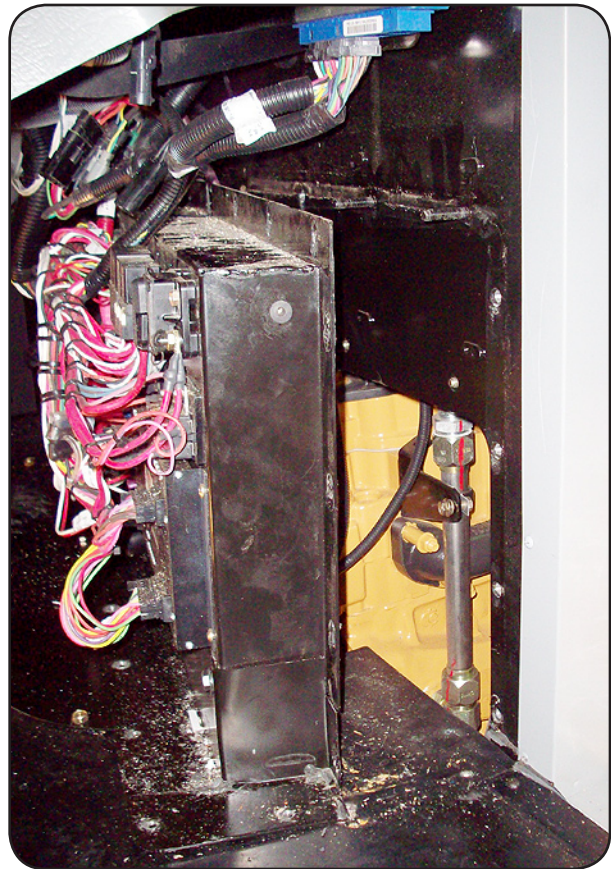
PDU pulled outward at right side to gain access to cables at rear of engine

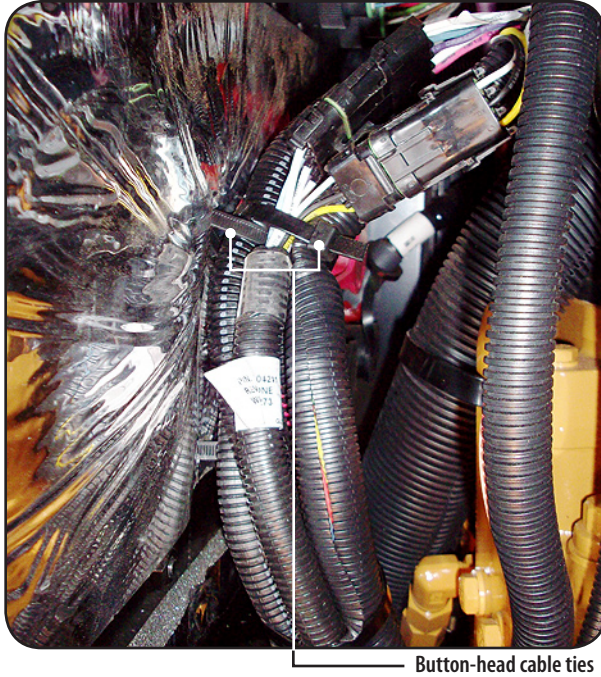
7.2 Locate the two button-head cable ties which secure battery cables to the PDU. If either of the button-head cable ties are broken, missing, or damaged during the removal of the PDU, install new button-head cable ties (0024706) before reinstalling the PDU.
