Safety Recall Circular

Code: **66D6**

**Subject: 2007-2009 Touareg 2
Roof Edge Spoiler**

REVISED
September 2009

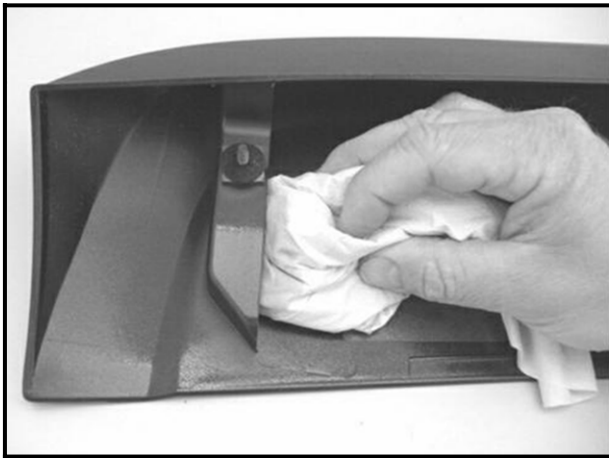
Tip: On some rear spoilers, reinforcements may have already been bonded and/or the middle reinforcement may not be filled

- ⇐ Clean and degrease all 3 areas of the attachments (for example, with cleaning solution D 009 401 04 – shop supply) and allow to completely dry
