Subject: Supplemental Information for Safety Recall 9LG
Potential Floor Mat Interference with Accelerator Pedal

2010 MODEL YEAR LEXUS IS250C, IS350C

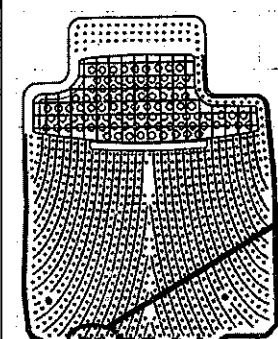
PT908-33072

Driver's floor mat part number is located on the bottom of the back side of the mat.

NOTE: Use the attached Application Information Chart to verify mat-to-vehicle application.
