Michael A. Berardi
Director
Service Engineering Operations
Ford Customer Service Division

October 13, 2009

SUBJECT: Safety Recall 09S09
Certain 1992-2003 Model Year Vehicle Lines
Speed Control System Modification

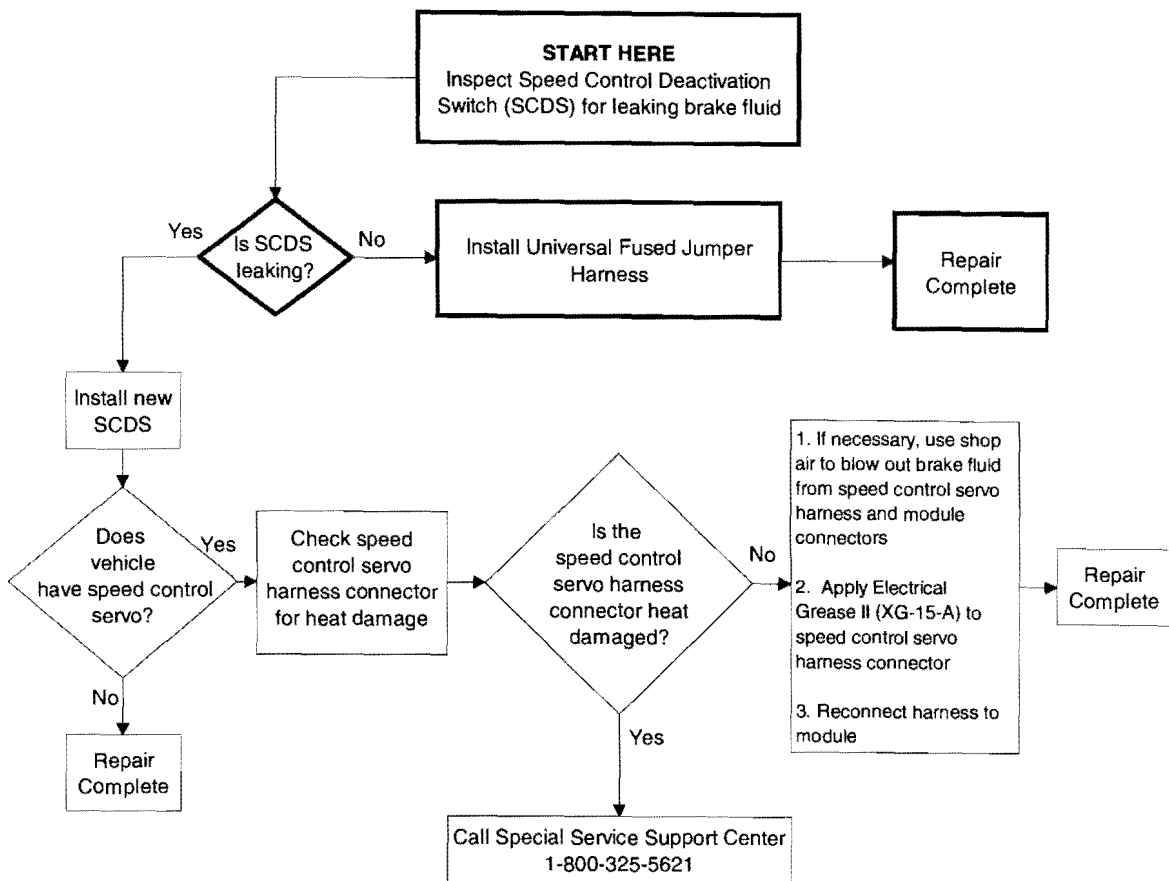
Flow Chart #1 shows the repair procedure for all affected vehicles except 1999 through 2003 Windstar vehicles.

- 1992-2003 E-Series
- 2000-2003 Excursion
- 1995-2002 Explorer
- 1993-1997, 1999-2003 F-Series Over 8500 GVW
- 1994 F53 Motorhome
- 1997, 2002 Mountaineer
- 1995-1997, 2001-2003 Ranger
- 1995-1998 Windstar

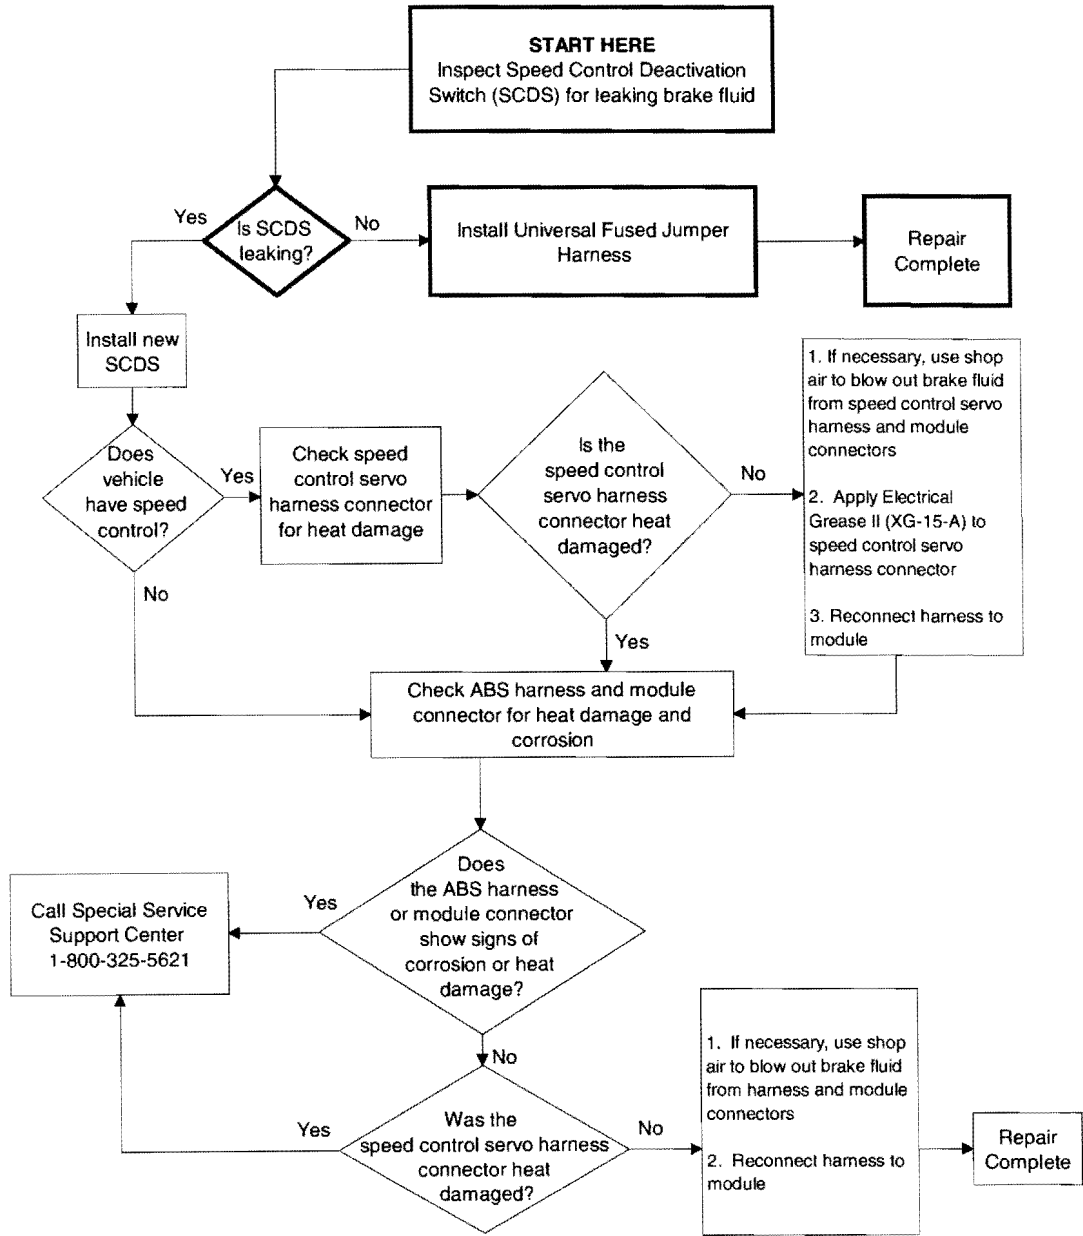
Flow Chart #2 shows the repair procedure for 1999 through 2003 Windstar vehicles.

1999-2003 Windstar
