May 26, 2016

**TO:** All U.S. Ford and Lincoln Dealers

**SUBJECT:** **Safety Recall 09S09 – Supplement #1**  
Certain 1992-2003 Model Year Vehicle Lines  
Speed Control System Modification

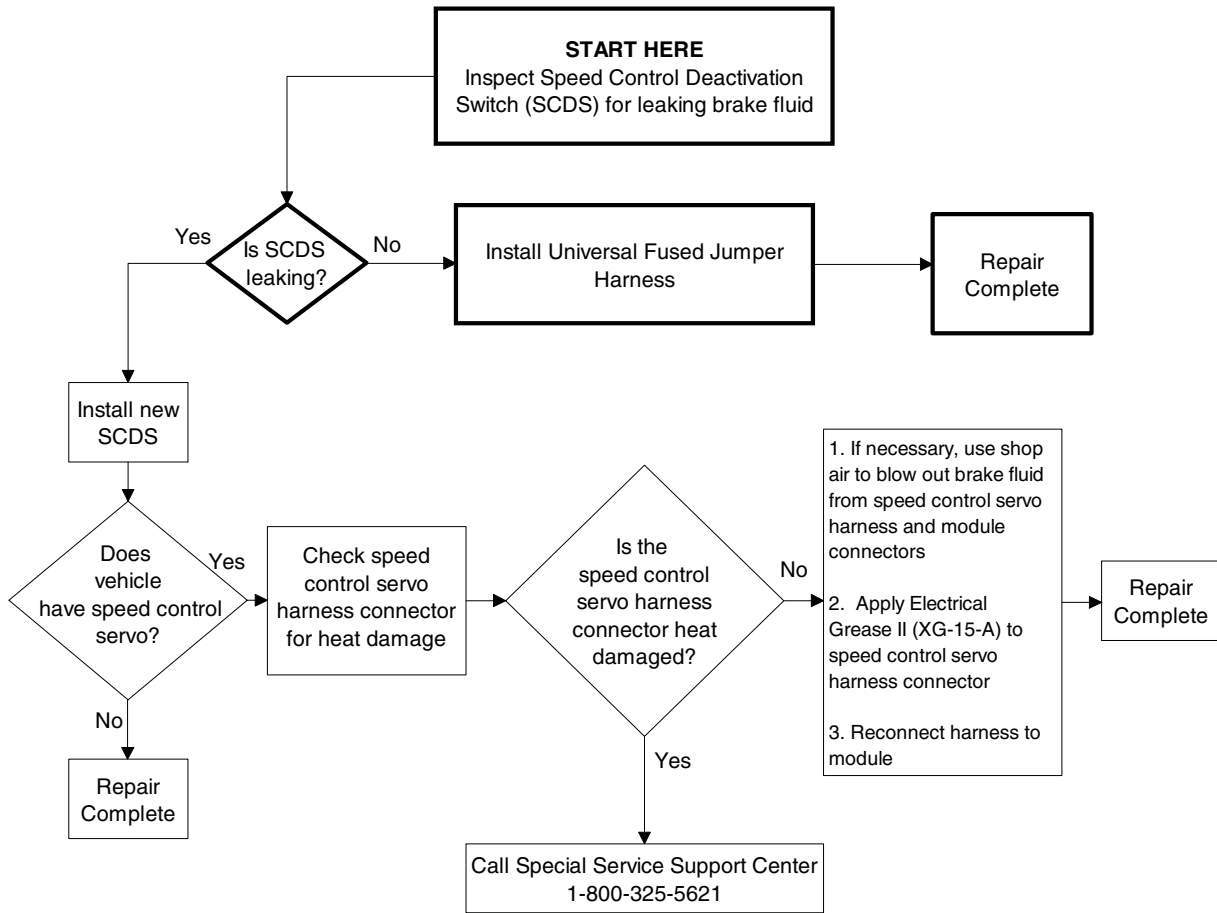
### Flow Chart #1

Flow Chart #1 shows the repair procedure for all affected vehicles except 1999 through 2003 Windstar vehicles.

- 1992-2003 E-Series
- 2000-2003 Excursion
- 1995-2002 Explorer
- 1993-1997, 1999-2003 F-Series Over 8500 GVW
- 1994 F53 Motorhome
- 1997, 2002 Mountaineer
- 1995-1997, 2001-2003 Ranger
- 1995-1998 Windstar

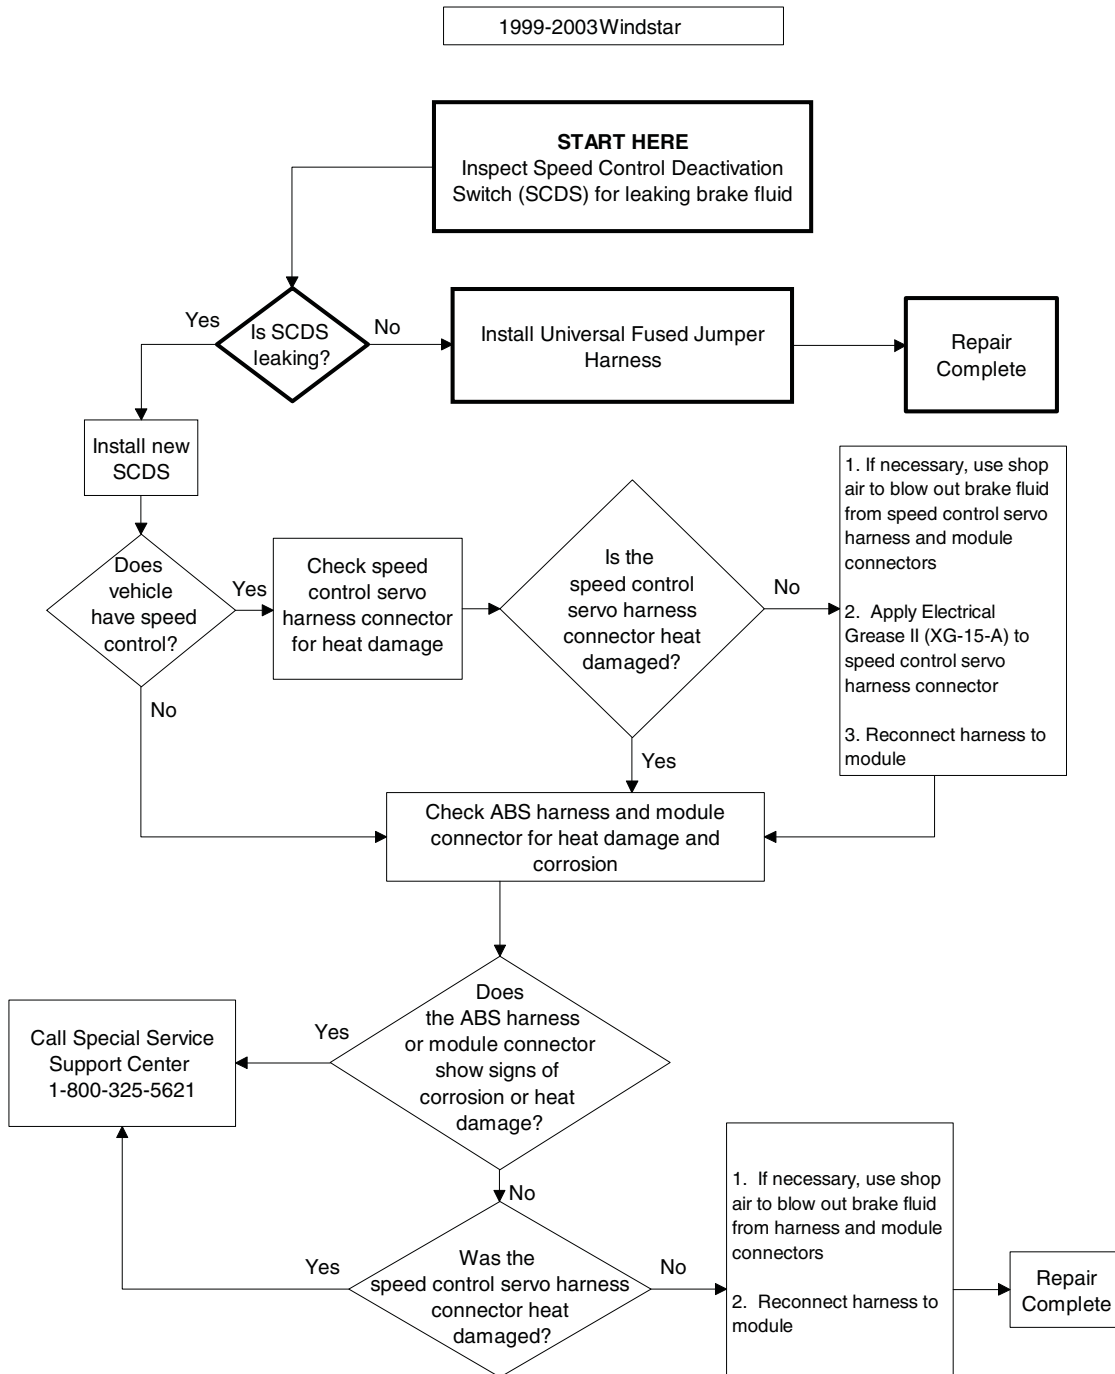
**Flow Chart #2**

In addition, for 1999 through 2003 Windstar vehicles, the repair includes an inspection of the Anti-lock Brake System (ABS) connectors. See Flow Chart #2 on page 3.

Flow Chart #2 shows the repair procedure for 1999 through 2003 Windstar vehicles.
