TOYOTA CUSTOMER SERVICES

Volume: XVI
Number: TC10-015
Date: 03/08/2010
 Action
 Retain
 Information

Subject: Safety Recall (Special Service Campaign) – 90M
Certain 2000 – 2003 Model Year Toyota Tundra Vehicle in Severe Cold Climate States
Excessive Corrosion of the Rear Cross Member (Spare Tire Carrier)

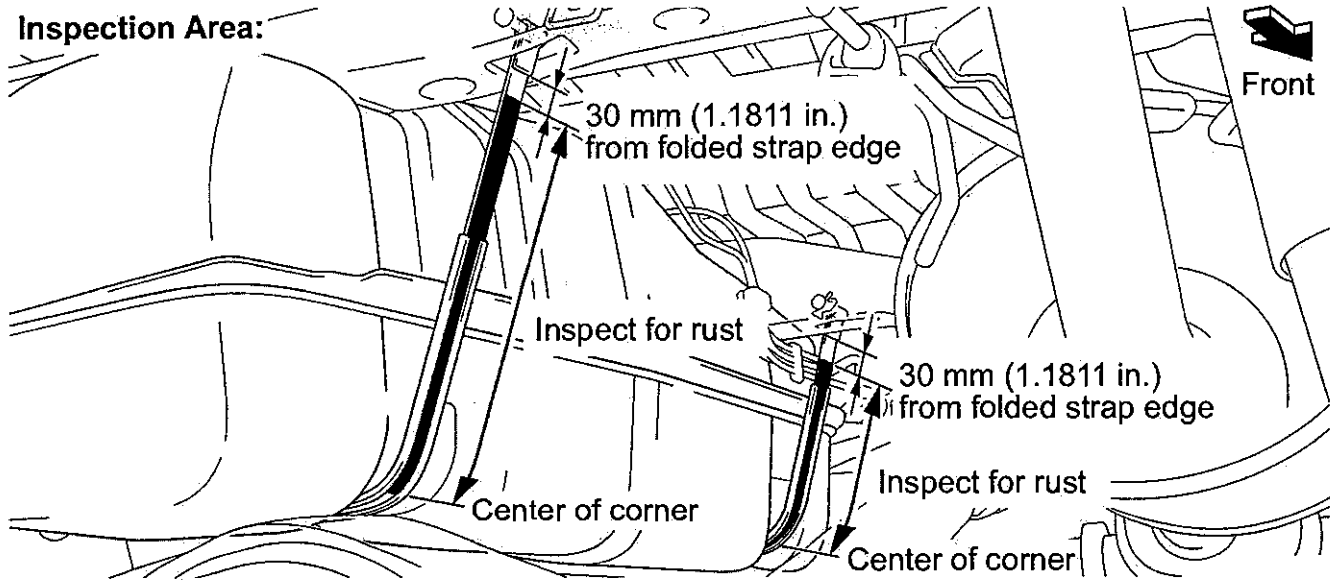
Inspection Area:

b) Inspect the outside surface of the fuel tank straps, does the rust span the width (front to rear) of either fuel tank strap as shown.

Rusting occurs continuously along the entire width of the strap.

Judgement Criteria	Action
NG	Replace the fuel tank strap(s) For part number information, please reference Section V "PARTS INFORMATION"
OK	Replacement not required

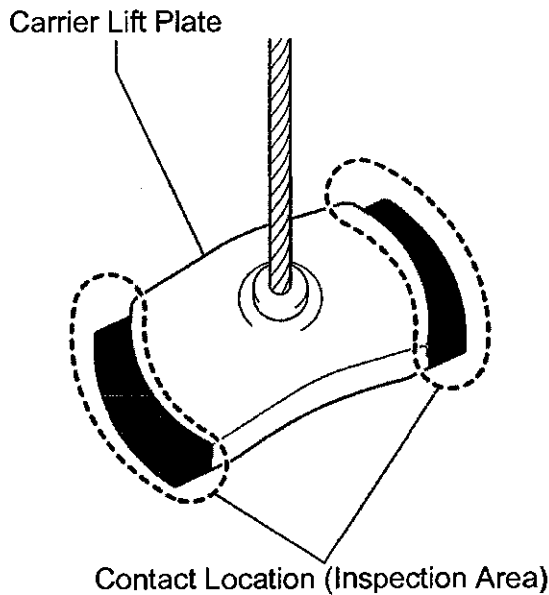
a) Inspect the spare tire carrier lift plate as shown.

Rust but no deterioration or holes present

Judgement Criteria	Result	Action
Deterioration Found	NG	Replace the spare tire carrier For part number information, please reference Section V "PARTS INFORMATION"
No Deterioration	OK	Replacement not required
