TOYOTA

Subject: Safety Recall (Special Service Campaign) – 90M
Certain 2000 – 2003 Model Year Toyota Tundra Vehicle in Severe Cold Climate States
Excessive Corrosion of the Rear Cross Member (Spare Tire Carrier)

REAR FRAME CROSS MEMBER REPLACEMENT

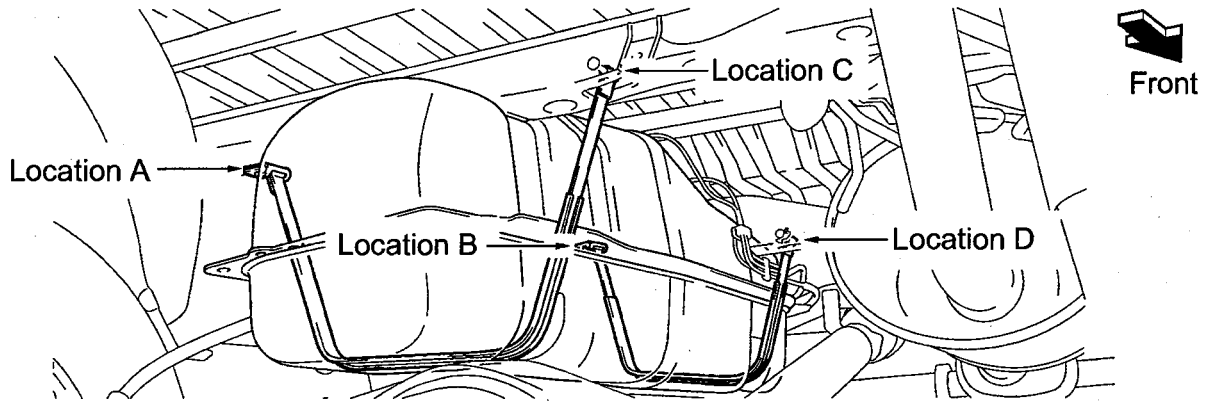
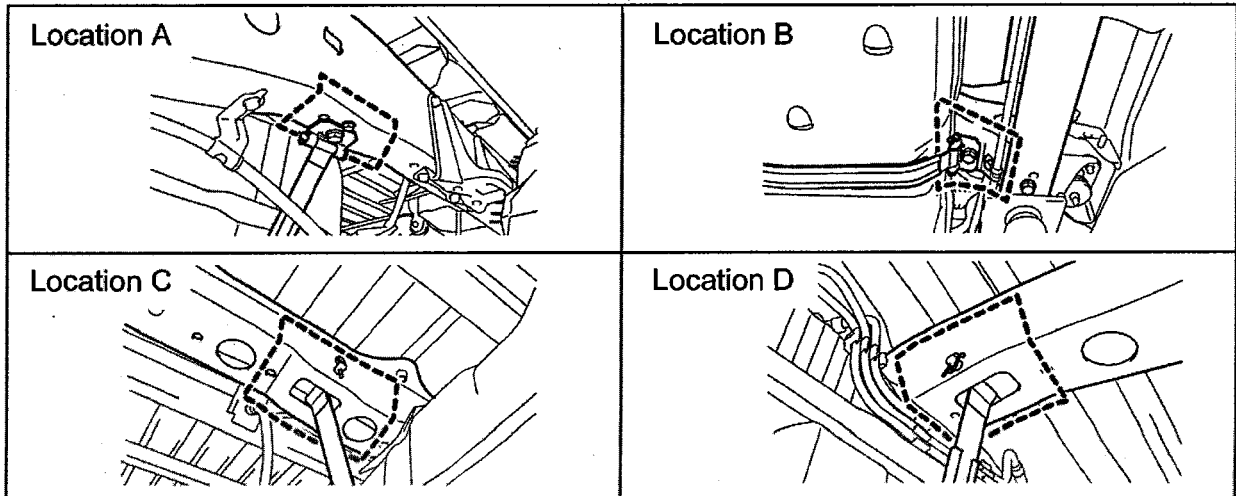
2. INSPECT THE FUEL TANK MOUNTING CROSS MEMBERS FOR RUST PERFORATION

NG	Replace the frame
<ul style="list-style-type: none"> 2 perforations (holes) within 10 mm of each other in locations A, B, C or D, see below

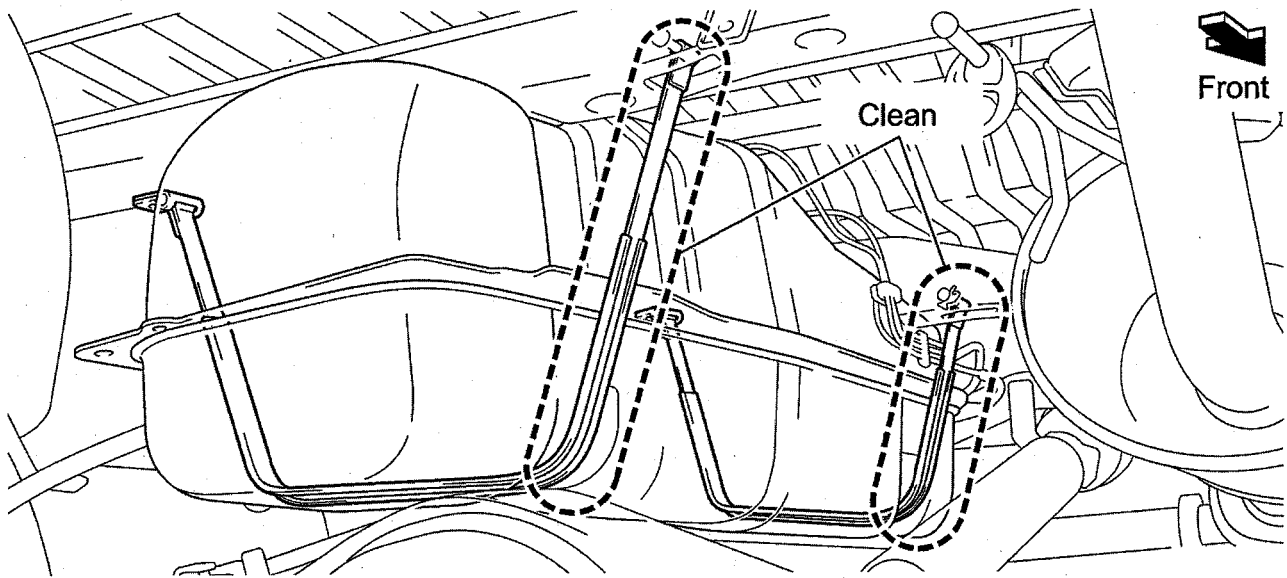
1. INSPECT THE FUEL TANK STRAPS FOR CORROSION DAMAGE

b) Inspect the outside surface of the fuel tank straps, does the rust span the width (front to rear) of either fuel tank strap as shown.

Rusting occurs continuously along the entire width of the strap.

Rusting does not occur continuously along the entire width of the strap.

Judgement Criteria	Action
NG	Replace the fuel tank strap(s) For part number information, please reference Section V "PARTS INFORMATION"
OK	Replacement not required
