Audi of America, Inc.

SAFETY RECALL CAMPAIGN ANNOUNCEMENT

Subject: **Voluntary Safety Recall Campaign 70D4/J6
2009 Audi Q5 vehicles
Replace Middle Clip of A –Pillar Cover**

Safety Recall Circular

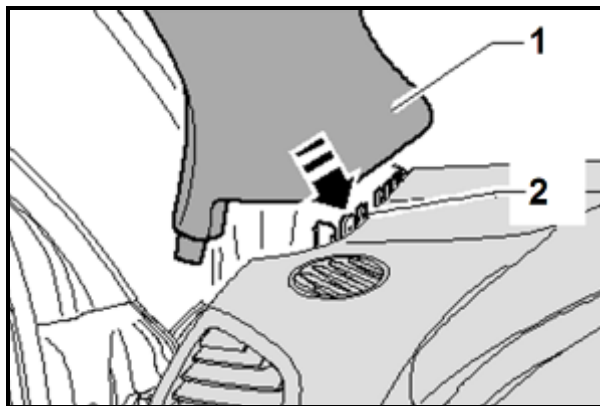
Be very careful not to trap curtain airbag when installing A-pillar trim

- ⇐ Install upper A-pillar trim -1- into instrument panel mount -2- and front sill panel trim -direction of arrow-
- Attach upper A-pillar trim panel with the “AIRBAG” symbol so that the clips engage
- Fold over the rubber lip of door seal
