# Recall Campaign

Daimler Trucks  
North America LLC

February 2010  
FL557AB  
NHTSA #09V-357

### Subject: Rack and Pinion Steering Inner Tie Rod Ends

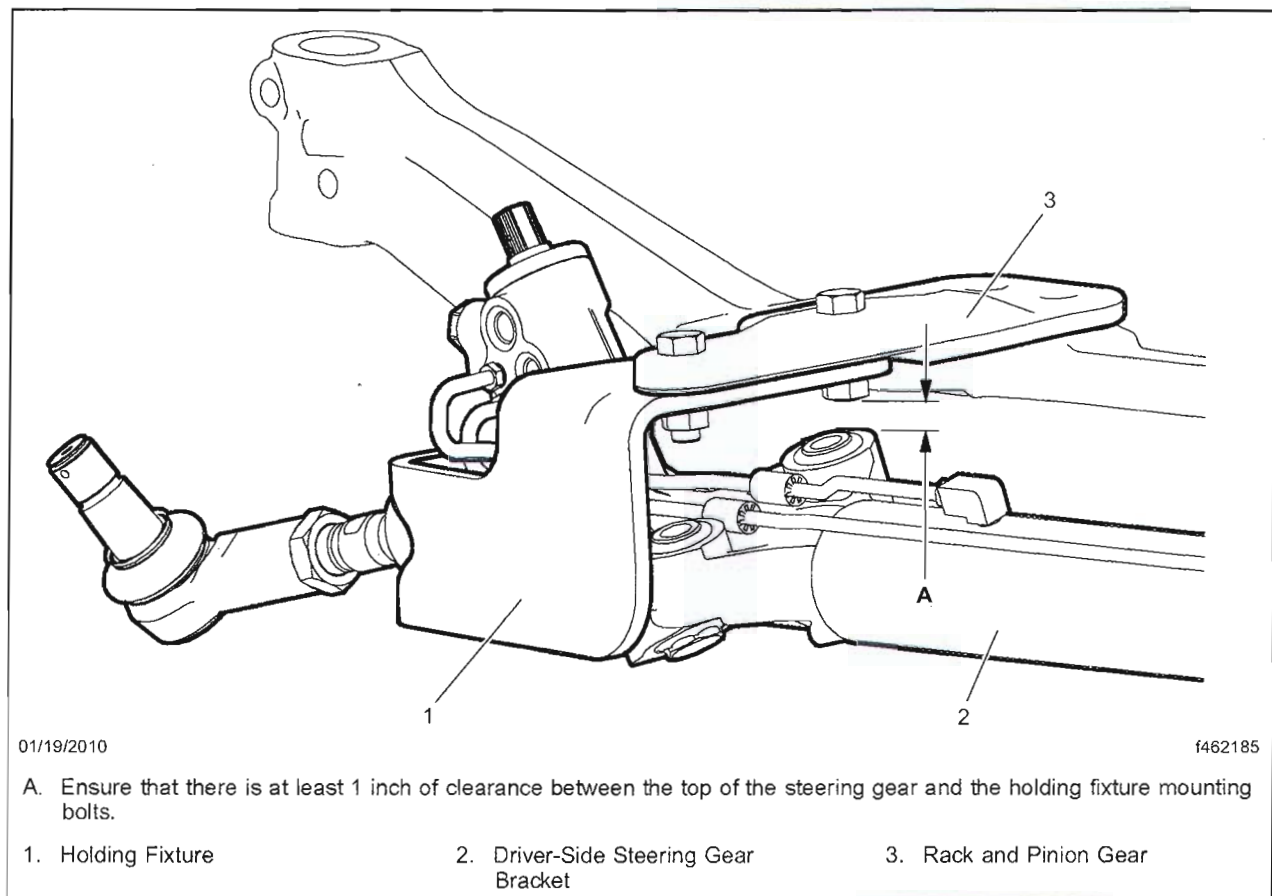
**Fig. 3, Rack and Pinion Gear Engaged in Holding Fixture**

- 12.4 Ensure that there is at least 1 inch of clearance between the top of the steering gear and the holding fixture mounting bolts. See **Fig. 3**.

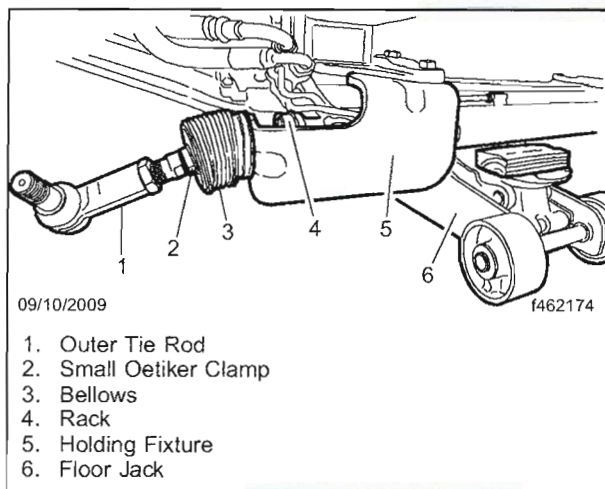
**Fig. 4, Holding Fixture Installation**

- 12.5 Ensure that the floor jack no longer supports the gear. See **Fig. 4**. The rack should be parallel to the ground, and the rack flats should be fully engaged in the fixture.

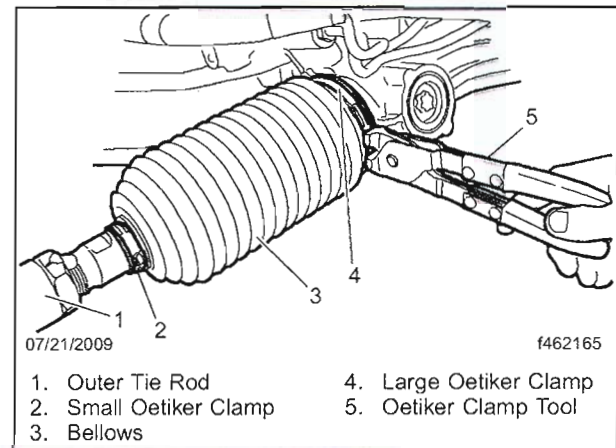
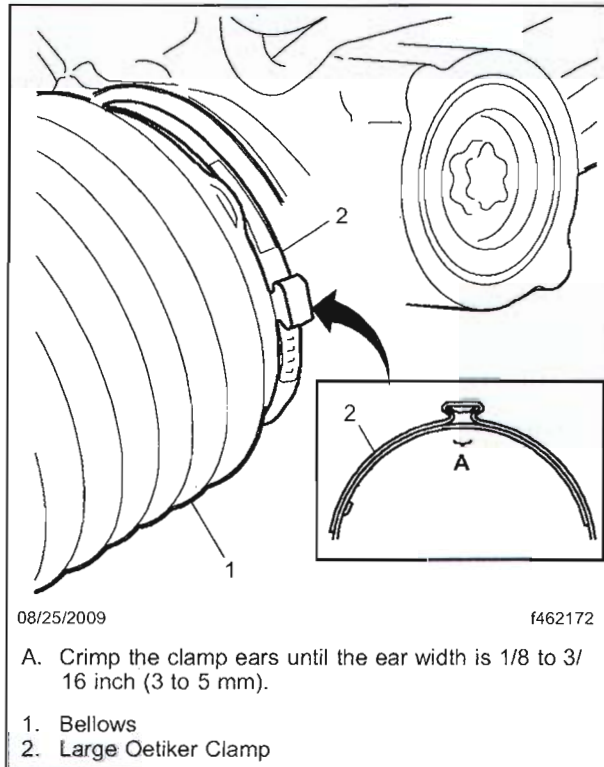
**Fig. 8, Oetiker Clamp Installation**

**IMPORTANT: All three barbs on the clamp must be engaged. If all three barbs are not engaged after crimping, remove and discard the clamp and install a new clamp. Oetiker clamps must be adequately crimped and the boot must be tightly secured to the gear housing to prevent moisture intrusion and corrosion.**

27. Using an Oetiker clamp tool, crimp the large Oetiker bellows clamp ear until the inner ear width is 1/8 to 3/16 inch (3 to 5 mm). See Fig. 8 and Fig. 9.
