Reference: NHTSA Identification Number 09E-001

April 2009

Dealer Service Instructions for:

## **Safety Recall H46 - Mopar Steering Linkage**

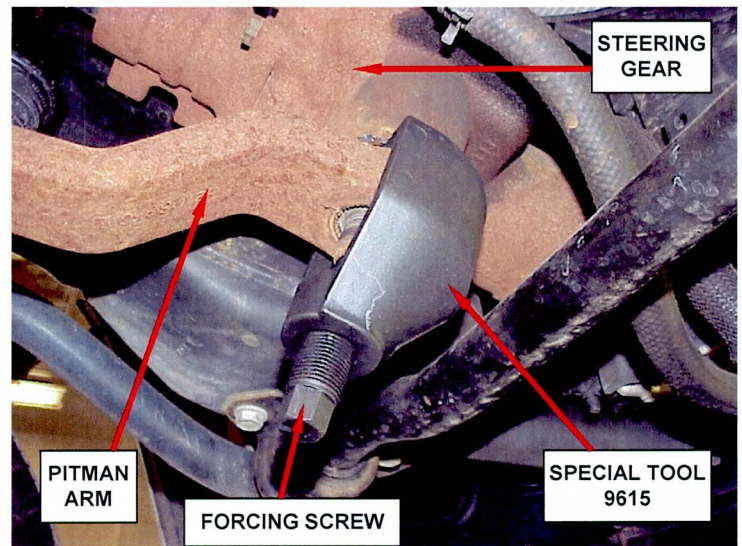
**Figure 10 - Special Tool 9615**

**CAUTION: Failure to use the correct pitman arm puller could cause damage to the steering gear.**

7. Replace the inner drag link joint and pitman arm using the following procedure:
  - a. Loosen both drag link adjuster sleeve clamp nuts (Figure 7).
  - b. Remove and save the pitman arm retaining nut located on the steering gear output shaft.
  - c. Install pitman arm puller (Special Tool 9615) onto the steering gear output shaft (Figure 10).

- d. Tighten the pitman arm puller forcing screw until the pitman arm separates from the steering gear output shaft (Figure 10).
- e. While counting the number of turns, unscrew the steering inner drag link joint (with pitman arm still attached) from the drag link adjuster sleeve (right handed threads) and discard the pitman arm and inner drag link joint.

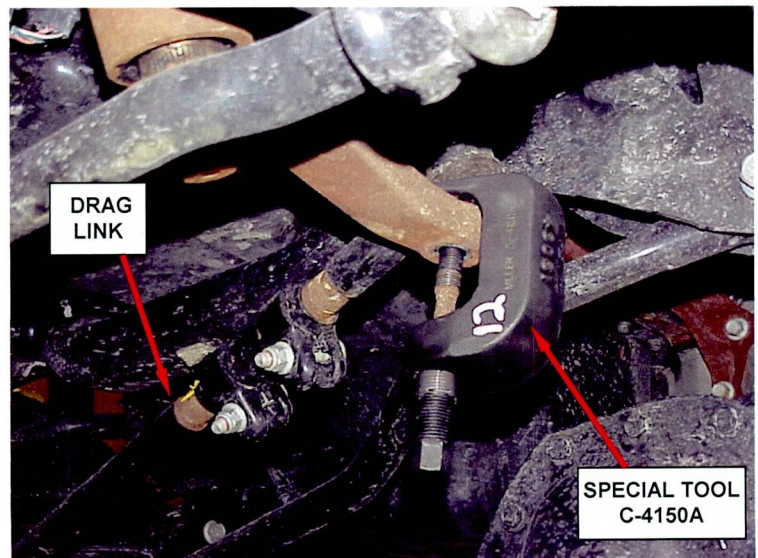
**Figure 13 – Special Tool C-4150A**

**CAUTION:** Use extreme care not to tear, nick or damage the inner drag link joint rubber boot.

- Use Special Tool C-4150A to separate the steering inner drag link joint from the pitman arm (Figure 13).

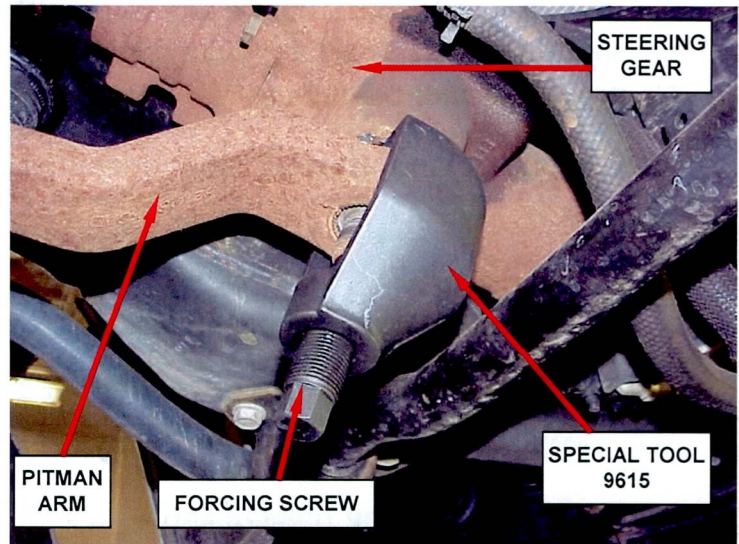
**Figure 14 - Special Tool 9615**

**CAUTION:** Failure to use the correct pitman arm puller could cause damage to the steering gear.

- d. Install pitman arm puller (Special Tool 9615) onto the steering gear output shaft (Figure 14).

- e. Tighten the pitman arm puller forcing screw until the pitman arm separates from the steering gear output shaft (Figure 14).
