Attached you will find documents related to campaign 5209A – 2009 Mazda6 Outer Door Handle Voluntary Safety Recall.

SUBJECT: 2009 MAZDA6 Outer Door Handle Voluntary Safety Recall 5209A

2009 MAZDA6 - Outer Handle Recall Campaign [5209A]**A. VEHICLE INSPECTION PROCEDURE**

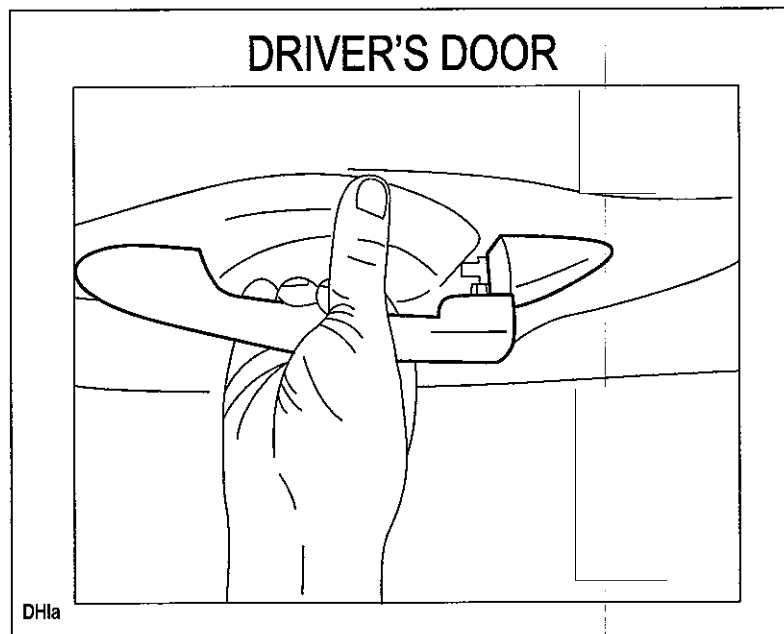
5. Position thickness gauge (0.05mm) at lever sliding area as indicated below.

NOTE: Tip of gauge touches counter weight (metal part - gray) and side is parallel to handle cap.

7. Check if thickness gauge can be moved freely.
 - If gauge is stuck and force is required to remove it, outer handle is "Suspect", document outer handle type (Standard Keyless Entry or Advanced Keyless Entry) on Repair Order. Proceed to Step 8.

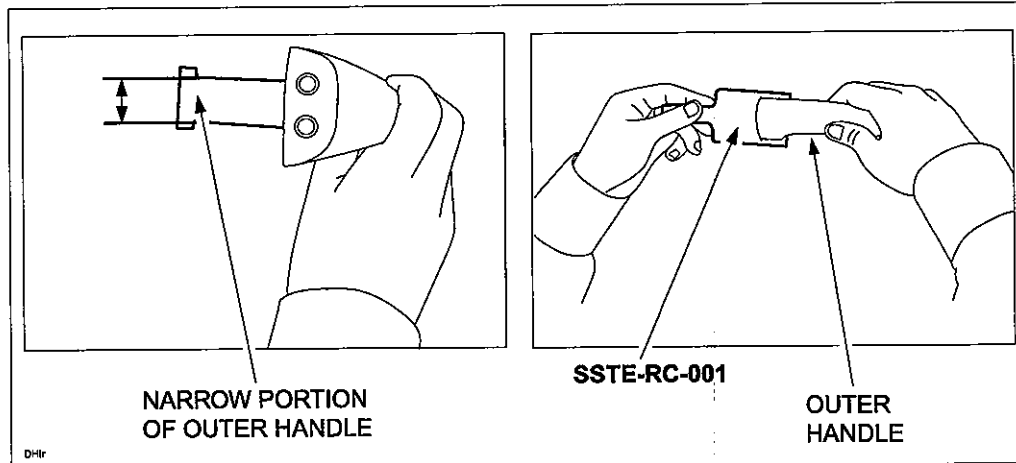
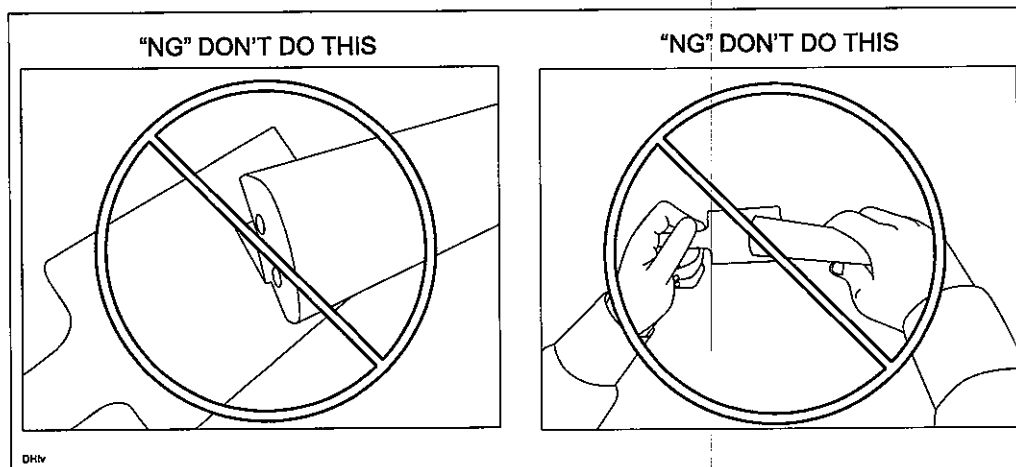
1. Using **SST SSTE-RC-001**, check the outer handle by inserting it into the female end of the SST (holding both outer handle and SST horizontally) until flat surface of outer handle meets flat surface of SST.

NOTE: Inspection checks dimensions of narrow portion of outer handle.

NOTE: Be careful not to insert or hold outer handle at an angle, otherwise, it could bind and lead to a false failure.

2. Slide the SST across the narrow area of the outer handle.
3. Slide the SST end-to-end (full stroke) over the entire surface of the outer handle.
 - If the outer handle does not fit into the SST, it fails the inspection.
 - If it takes excessive effort to slide the outer handle through the SST (SST should move freely with some resistance), it fails the inspection.

- If outer handle fails inspection, document outer handle type (Standard Keyless Entry or Advanced Keyless Entry) and location (LF, RF, LR, RR) on Repair Order. Proceed to "E. REPAIR PROCEDURE".
- If outer handle passes inspection, proceed to "**Handle Bracket Inspection**" to check handle bracket with male end of SST.

1. Replace failed outer handle, or replace handle bracket (front door with Advanced Keyless Entry only).

- FRONT PASSENGER DOOR AND REAR DOORS: Install new outer handle in reverse order of "C. OUTER HANDLE REMOVAL" procedure.
- DRIVER'S DOOR: Replace outer handle according to Workshop Manual (section 09-14 FRONT OUTER HANDLE REMOVAL/INSTALLATION).

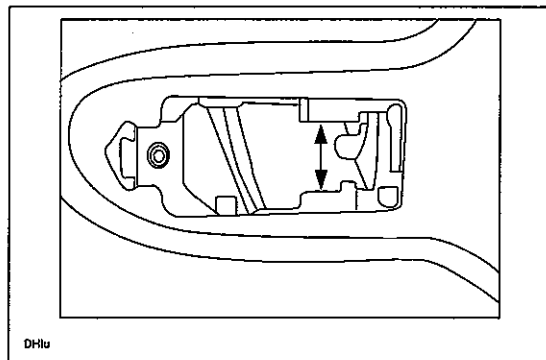
NOTE: Inspection checks dimension of handle bracket.

4. Using **SST SSTE-RC-001**, check the handle bracket mating surface. Insert the male end of the SST into handle bracket at the position shown below.
- If the SST does not fit into the handle bracket, it fails the inspection.
 - If the SST does not slide fully into the handle bracket (minimal resistance is okay), it fails the inspection.

- If handle bracket fails inspection, document outer handle type (Standard Keyless Entry or Advanced Keyless Entry) and location (LF, RF, LR, RR) on Repair Order. Proceed to "E. REPAIR PROCEDURE".
- If handle bracket passes inspection, reinstall original outer handle. Proceed to "F. CAMPAIGN LABEL INSTALLATION".

- FRONT DOORS ONLY: Replace handle bracket according to Workshop Manual (section 09-14 FRONT OUTER HANDLE REMOVAL/INSTALLATION).
