From: Technical Services Department
Sent: Thursday, April 23, 2009 3:48 PM
Subject: Upcoming 2010 Mazda3 Emission Harness Voluntary Safety Recall 5409D
Attachments: eFC-I-09-00034b.pdf

Mazda Motor Corporation has decided that a defect which relates to motor vehicle safety exists in certain 2010 Mazda3 vehicles equipped with LF or L5 engine and produced from October 7, 2008 through April 10, 2009.

On certain 2010 Mazda3 vehicles, the clearance between the emission harness and the housing of the starter motor may be insufficient. Due to this, the covering of the harness may be damaged from vibration during operation, resulting in a short-circuit between the harness wires and the starter housing. This condition could cause an engine control malfunction and/or poor shift quality. In the worst case, the main fuse may blow out, causing the engine to stall and an inability to restart, increasing the risk of a crash.

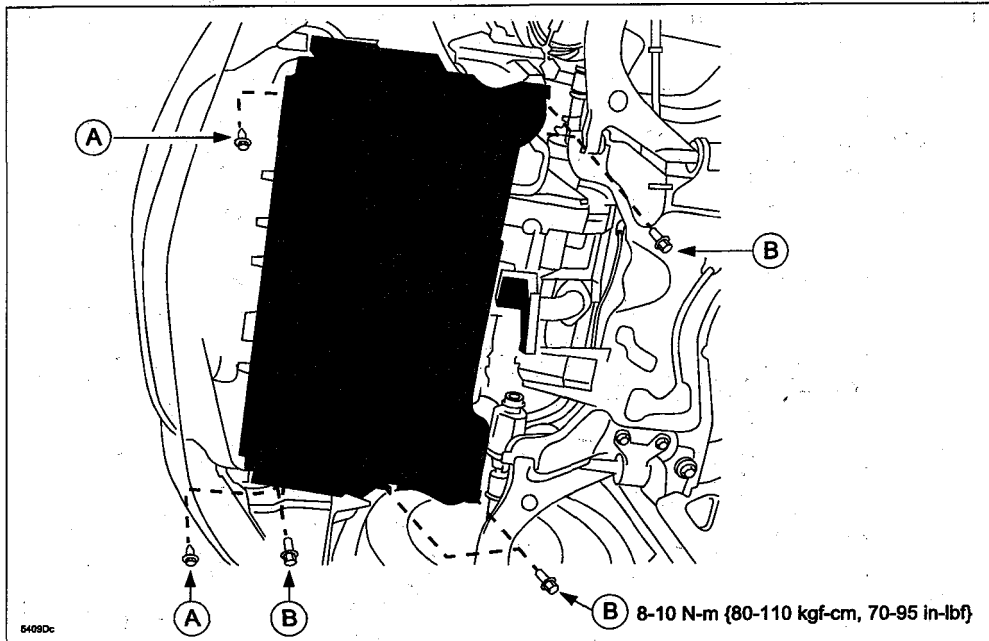
3. Carefully inspect the harness (A) in the area closest to the engine starter housing (B).
DOES THE HARNESS TOUCH THE ENGINE STARTER HOUSING?
- YES – Go to next step.
 - NO – Go to PROCEDURE "B".

1. Lift vehicle on hoist to access the undercover.
2. Remove the fasteners (A) and bolts (B) to remove the undercover from the vehicle.

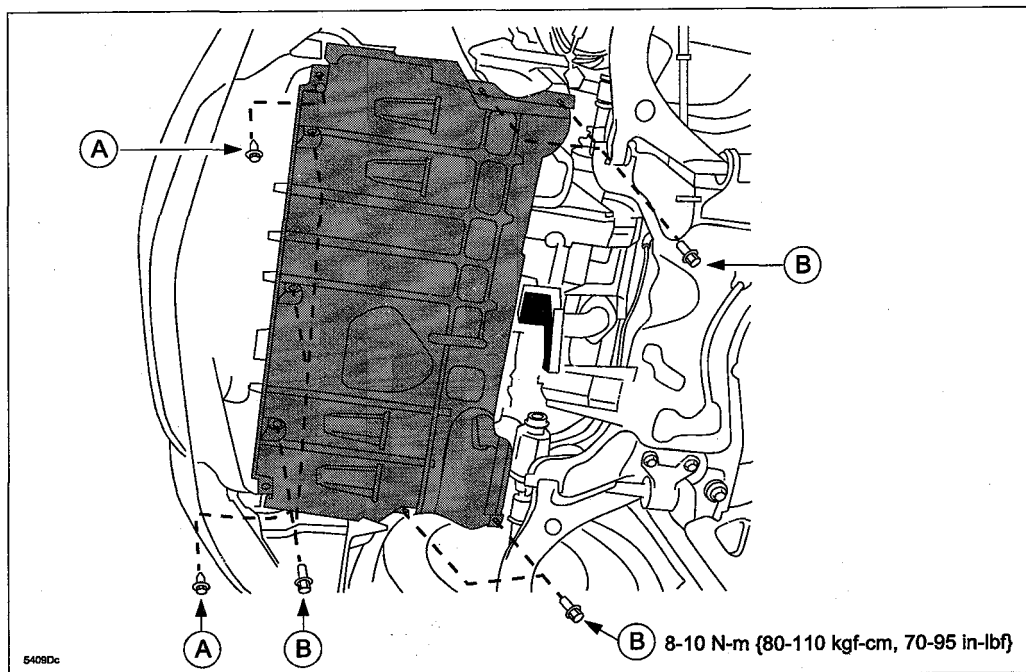
3. Carefully inspect the harness (A) in the area closest to the engine starter housing (B).
DOES THE HARNESS TOUCH THE ENGINE STARTER HOUSING?
 - YES – Go to next step.
 - NO – Go to PROCEDURE "B".

1. Lift vehicle on hoist to access the undercover.
2. Remove the fasteners (A) and bolts (B) to remove the undercover from the vehicle.
