Safety Recall Circular

Code: **40J2**

Subject: 2006-2009 Jetta (5th Generation) and 2009 Jetta SportWagen with 2.0L TFSI Engine and DSG Transmission

Inspect and, if Necessary, Replace Driveshaft Screws November 2009

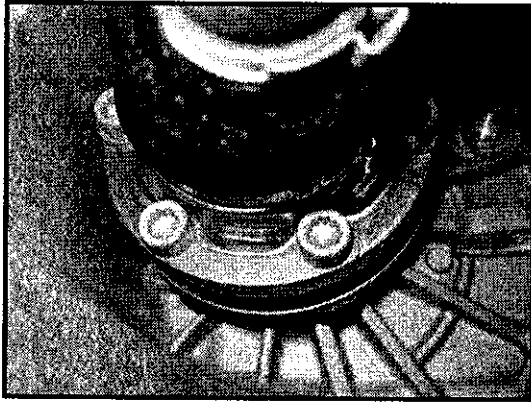
**Tip:** Replace driveshaft on one or both sides, as necessary

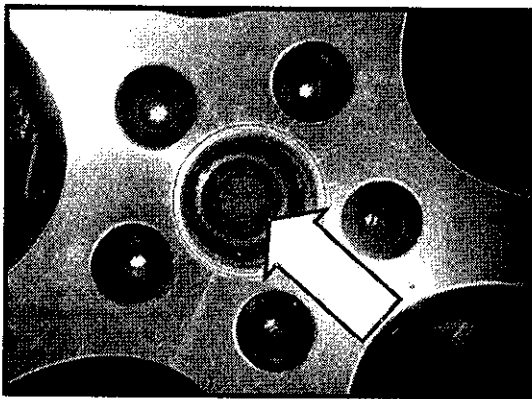
**Note:** DO NOT REMOVE driveshaft to wheel hub bolt with wheel bearings loaded by the vehicle's own weight. Damage to wheel bearings will occur under this condition and are not covered under this action

⇐ Lower vehicle on hoist and loosen driveshaft to wheel hub bolt -arrow- using T10361 (or equivalent) a maximum of 90°
