# Safety Recall Circular

Code: 40J2

**Subject: 2006-2009 Jetta (5<sup>th</sup> Generation) and 2009 Jetta SportWagen  
with 2.0L TFSI Engine and DSG Transmission  
Inspect and, if Necessary, Replace Driveshaft Screws**

**REVISED**  
July 2009

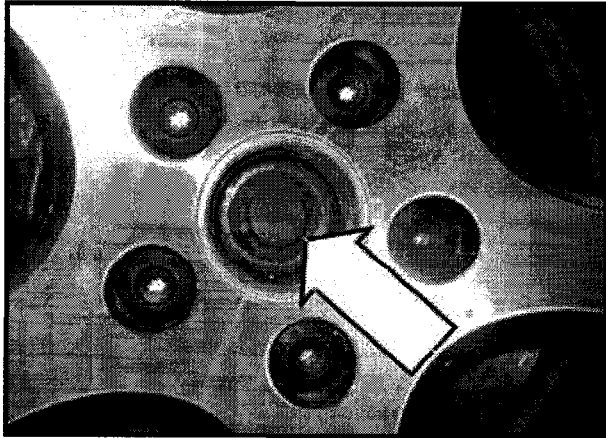
① Note: DO NOT REMOVE driveshaft to wheel hub bolt with wheel bearings loaded by the vehicle's own weight. Damage to wheel bearings will occur under this condition and are not covered under this action

② Note: Vehicles without a driveshaft must not be moved; otherwise, the wheel bearing will be damaged  
If the vehicle must be moved, always first install an outer CV joint in place of the driveshaft and torque to 120 Nm (89 ft-lbs)

- Raise vehicle on hoist until wheels hang freely
- ⇐ With the aid of a second technician, press brake pedal and remove driveshaft to wheel hub bolt -arrow- using T10361 (or equivalent)
