Safety Recall Circular

Code: **40J2**

Subject: 2006-2009 Jetta (5th Generation) and 2009 Jetta SportWagen with 2.0L TFSI Engine and DSG Transmission
Inspect and, if Necessary, Replace Driveshaft Screws

REVISED
April 2010

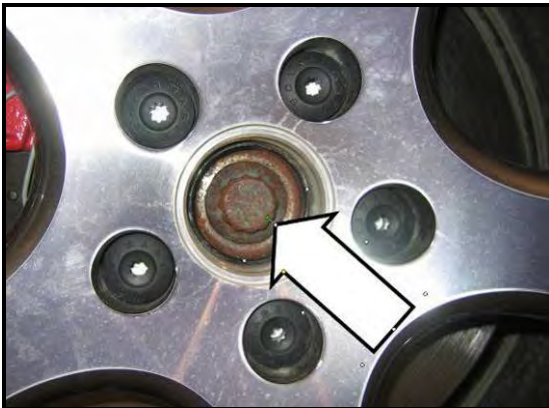
Note: DO NOT REMOVE driveshaft to wheel hub bolt with wheel bearings loaded by the vehicle's own weight. Damage to wheel bearings will occur under this condition and are not covered under this action

⇐ Lower vehicle on hoist and loosen driveshaft to wheel hub bolt -arrow- using T10361 (or equivalent) a maximum of 90°
