GROUP Campaign	MODEL 2001-2004MY Optima (MS)
NUMBER	DATE
SC 075	June 2009

SAFETY RECALL CAMPAIGN TECHNICAL SERVICE BULLETIN

REPAIR/REPLACEMENT OF SUBFRAME

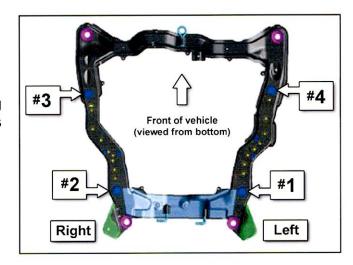
In preparation for the drilling of the 40 mm hole-saw cuts for the front / rear subframe sites, the following identification procedure must be utilized to ensure the proper drilling location. The 40 mm hole-saw site locations will be numbered as follows: (1-4) / (Large Blue Holes).
