## SAFETY RECALL

Sr09-10

| <b>SUBJECT : INSPECTION AND REPLACEMENT OF DRAG<br/>LINK SPHERICAL PLAIN BEARING ROD END</b> | |

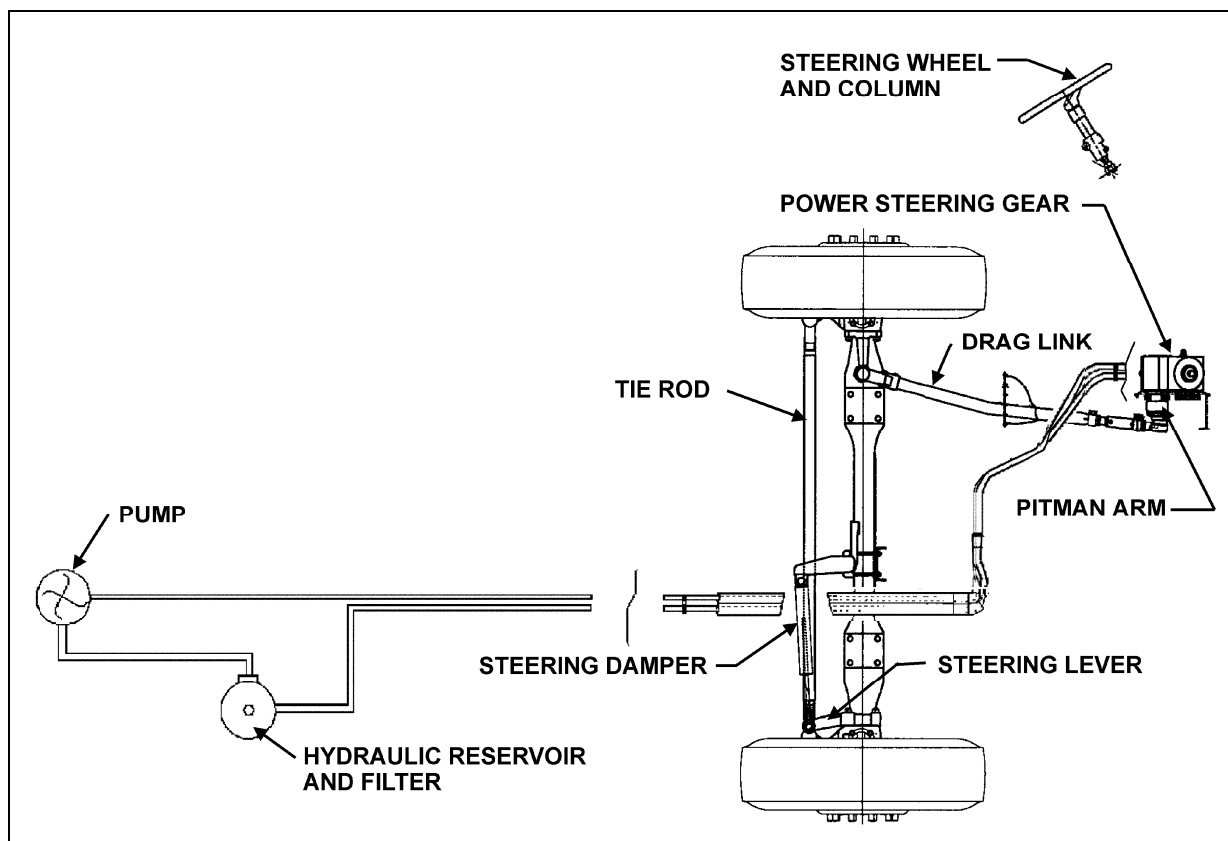
FIGURE 1

On items affected by this recall, material that may not meet Dana requirements for installation on the steering linkage of I-beam axle equipped vehicles have been purchased by you via Prevost Parts. Drag link end opening being off-centered, this can reduce the wall thickness below tolerances.

4. If measurement is outside tolerances, part 610991 must be replaced.
