Safety Recall Circular

Code: **66D6**

**Subject: 2007-2009 Touareg
Roof Edge Spoiler**

August 2009

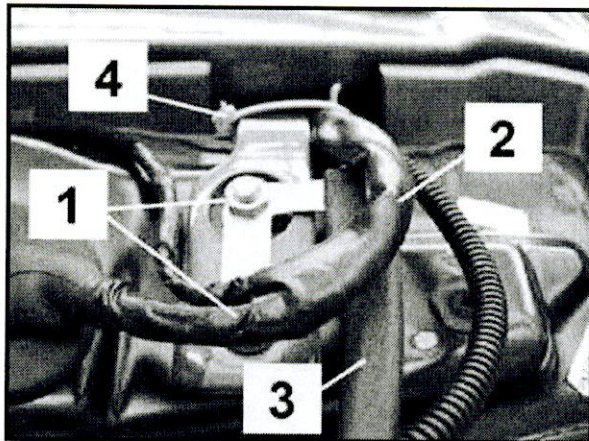
Tip: Due to bonding of the right reinforcement, the cable routing on the right side must be altered before reinstalling the rear spoiler

- ⇐ Remove nuts -1- and position the aerial -3- below the wiring loom -2- and retighten nuts to 9 Nm (7 lb-ft)
- ⇐ Install cable binder (N 909 377 02) -4- as shown, and clip excess material from cable binder
