## Subject: Rack and Pinion Steering Inner Tie Rod Ends

**Models Affected:** Specific Freightliner Cascadia, Century Class S/T, Columbia, and Coronado vehicles manufactured November 11, 2004, through July 20, 2009, with rack and pinion steering.

June 2010  
FL557AB  
NHTSA #09V-357  
REVISED NOTICE

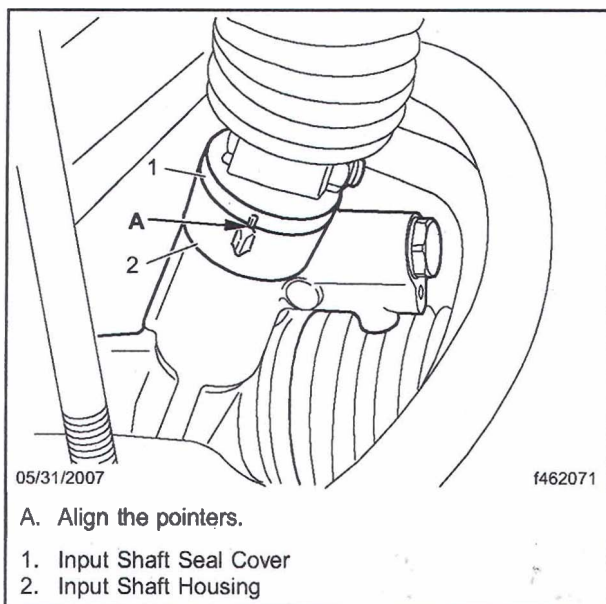
**Fig. 1, Pointer Alignment**

3. Turn the steering wheel one full rotation to the left to move the inner tie rod inward and align the gear for the following steps. Ensure the timing pointers on the input shaft seal cover and input shaft housing are aligned. See **Fig. 1**.

32.1 When the alignment process requires that the steering wheel be pointed straight ahead, align the steering rack on-center pointers instead, see Fig. 1
