TECHNICAL INSTRUCTIONS

SAFETY RECALL 9LG

ACCELERATOR PEDAL MODIFICATION

2006 – 2010 MODEL YEAR LEXUS IS250, IS250 AWD, IS350

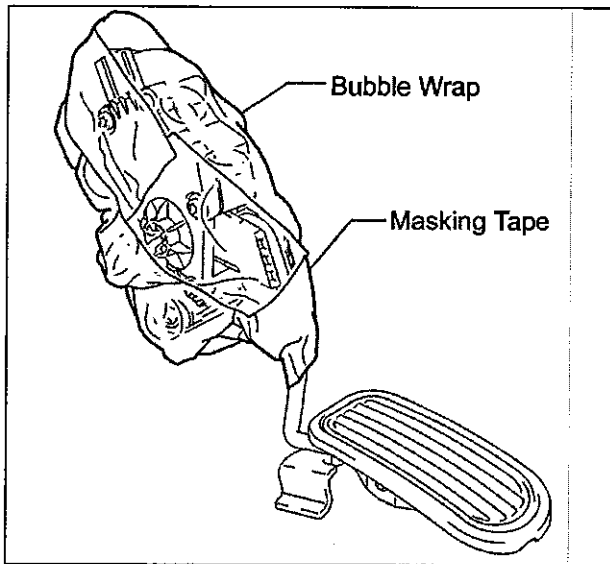
ACCELERATOR PEDAL HANDLING NOTES:

- DO NOT drop
- DO NOT reuse an accelerator pedal that has been dropped
- Avoid vibration and shock
- DO NOT place the sensor portion of the pedal in a vise
- Cover and uncover the sensor while in the vehicle to prevent damage and debris from entering

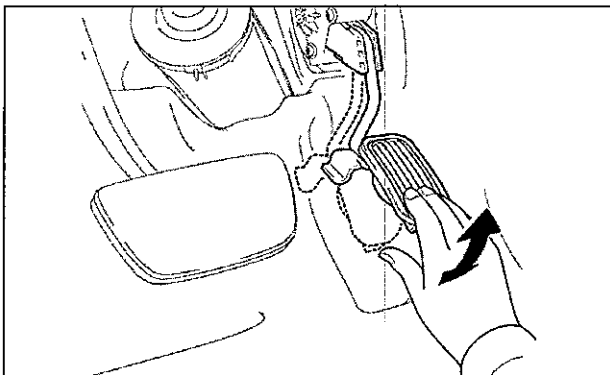
- b) Confirm the pedal does not get caught on the floor or floor mat during operation.
- c) Confirm the pedal operates properly.
