PRELIMINARY INSPECTION INSTRUCTIONS

SPECIAL SERVICE CAMPAIGN

**Rear Frame Cross Member &
Load Sensing Proportioning & By-Pass Valve Inspection**

2000-2003 Model Year Tundra

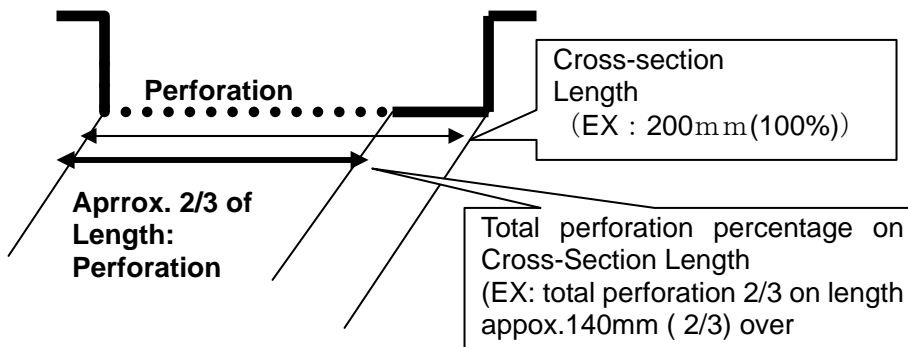
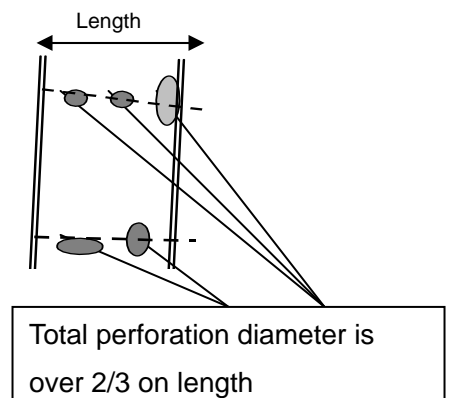
Rr. Cross - Member Cross - Section

Example of NG Condition: Replace Rear Cross Member

The length of perforation is more than 2/3 of the cross-section length.

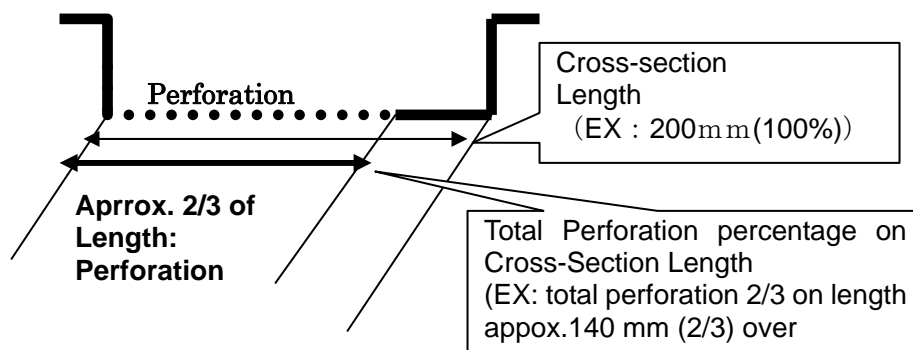
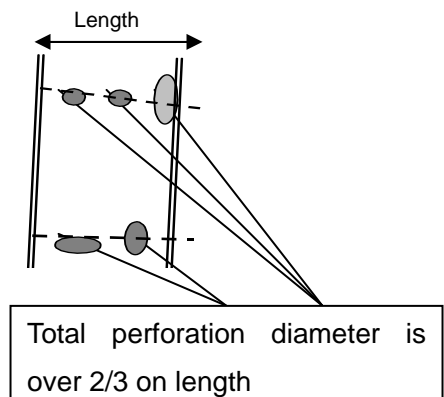
Rr. Cross - Member Cross - Section

Example of NG Condition: Replace Rear Cross Member

The length of perforation is more than $\frac{2}{3}$ of the cross-section length.

Vehicle should not be driven without rear cross member replacement
