CERTAIN 2009 MODEL YEAR F-650/750 VEHICLES – CHASSIS WIRING HARNESS CONNECTOR SEAL

OVERVIEW

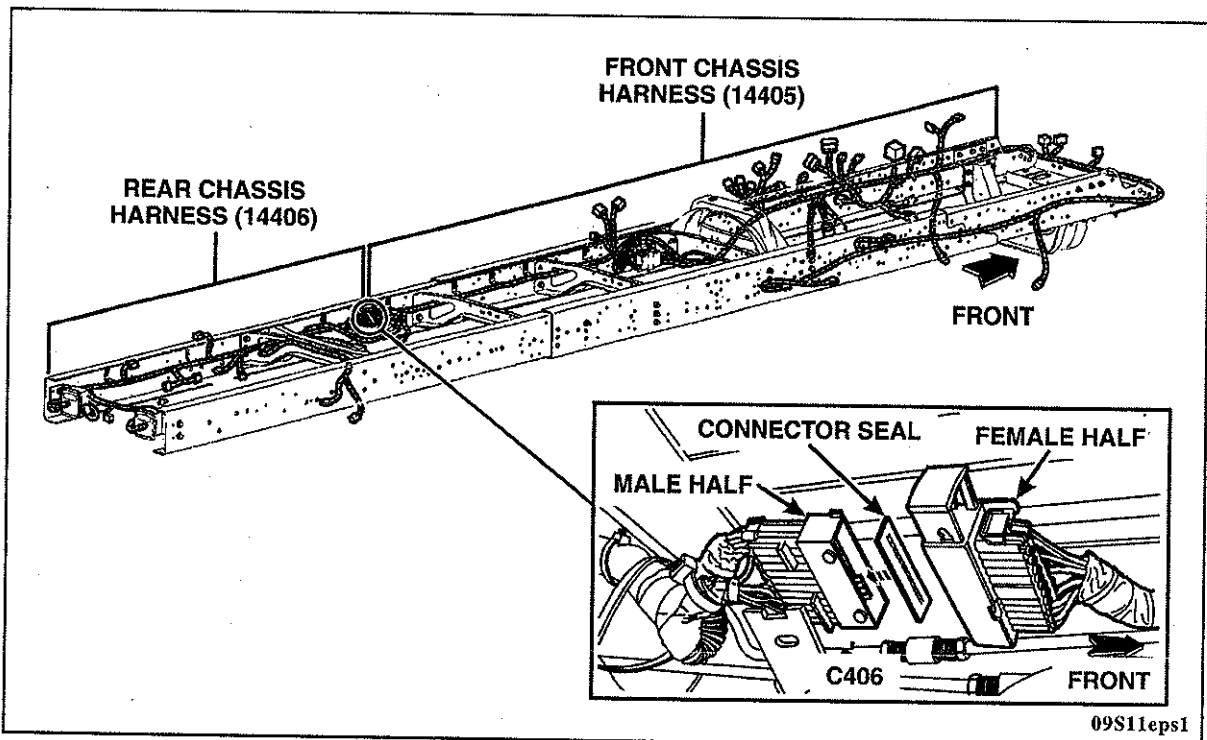
FIGURE 1

In some of the affected vehicles, the connector seal between the main chassis wiring harness and the rear chassis wiring harness may be missing.

Dealers are to inspect Connector 406 (C406) for the presence of the seal and/or terminal corrosion. Based on the results of the inspection, dealers will perform one of the following service actions:
