Safety Recall Circular

Code: 70D4
Subject: 2009 Q5
Replace Middle Clip of A-pillar Cover
December 2009
Claim Entry Procedure

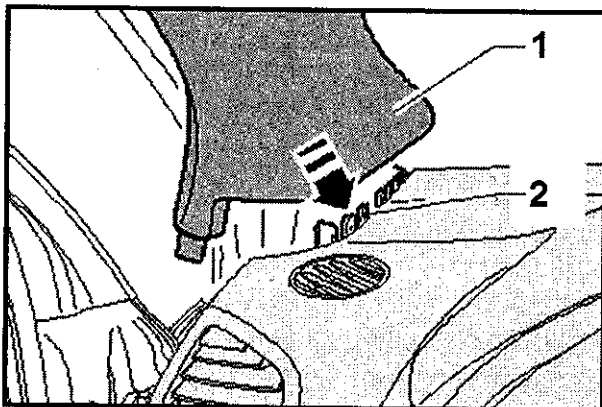
Be very careful not to trap curtain airbag when installing A-pillar trim

- ⇐ Install upper A-pillar trim -1- into instrument panel mount -2- and front sill panel trim -direction of arrow-
- ⇐ Attach upper A-pillar trim panel with the "AIRBAG" symbol so that the clips engage
- ⇐ Fold over the rubber lip of door seal
