# Recall Bulletin

**SUBJECT:** Engine Compartment Fire

**MODELS:** 1997-2003 Buick Regal  
2000-2003 Chevrolet Impala  
1998-1999 Chevrolet Lumina  
1998-2003 Chevrolet Monte Carlo  
1998-1999 Oldsmobile Intrigue  
1997-2003 Pontiac Grand Prix  
Equipped with a 3.8L V6 Naturally Aspirated Engine (RPO L36 - VIN K)

GM Recall #09047

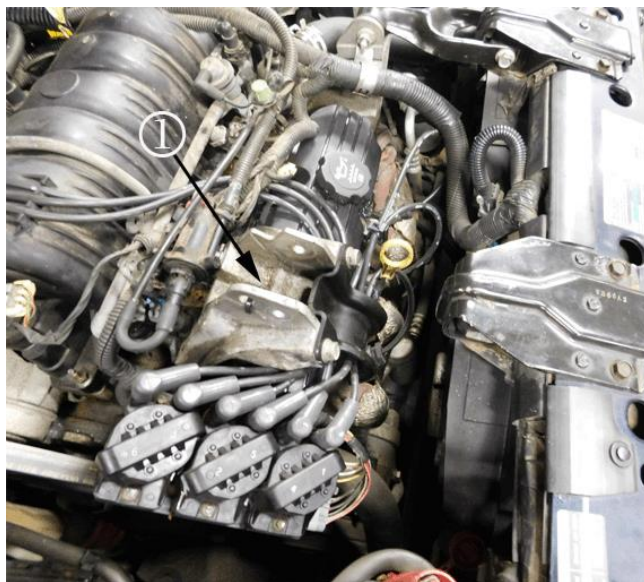
4358363

1. Remove the 1-3-5 spark plug wires from the ignition coils.

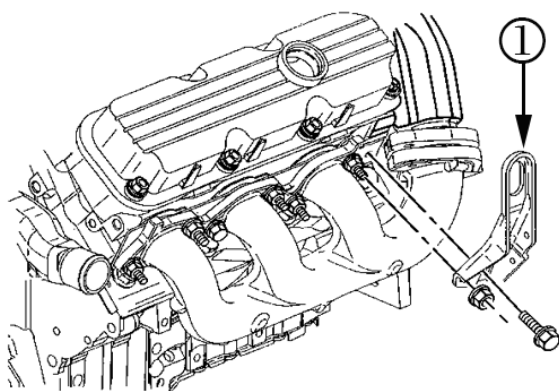
4358366

2. Remove the left engine mount strut bracket (1).

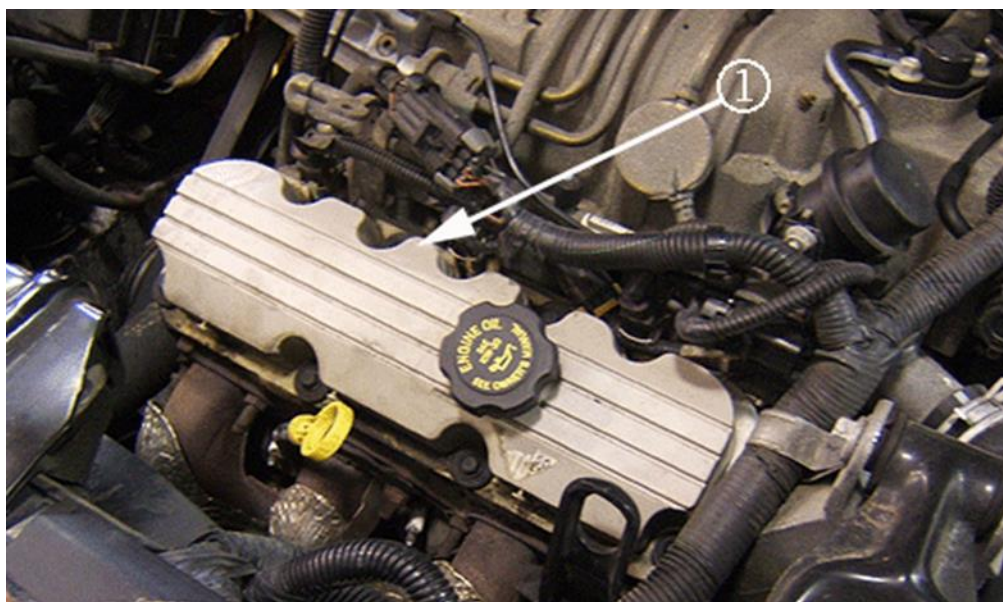
2074284

3. Loosen the left engine lift bracket (1) enough to allow clearance for the valve cover to be removed. It is not necessary to remove it from the engine.

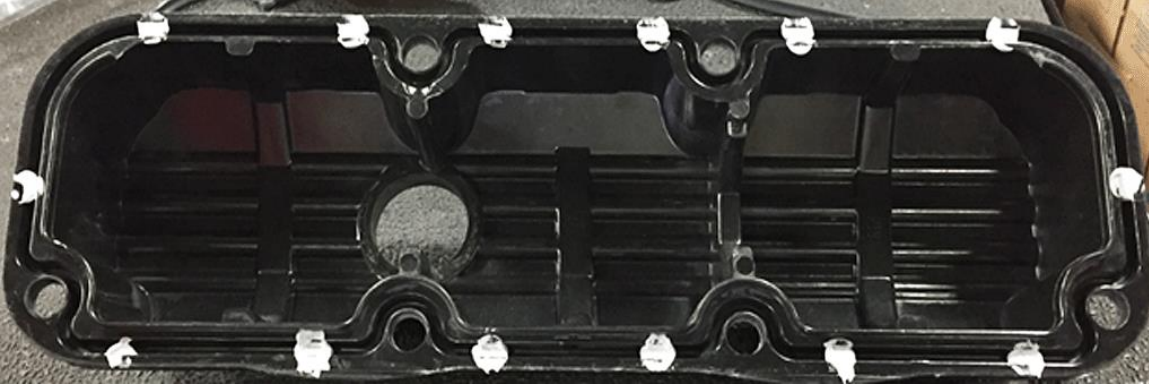
4596901

- 4.3. Clean the sealing surface on the cylinder head and the new valve cover with an engine degreaser or equivalent.
- 4.4. Clean the valve cover bolts of all dirt, grime or thread locking adhesive.
- 4.5. Clean the rubber grommets by wiping them off with a shop towel.

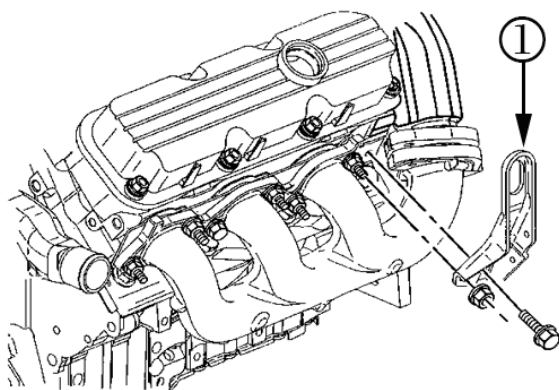
4358366

10. Install the left engine mount strut bracket.

- 10.1. Tighten the upper engine mount strut bracket bolts (1) to 50 Nm (37 lb ft).
- 10.2. Tighten the lower engine mount strut bracket bolts (2) to 50 Nm (37 lb ft).
- 10.3. Tighten the lower engine mount strut bracket nut (3) to 30 Nm (22 lb ft).
