Great Dane Trailers

10V-501
(5 Pages)

Re: 10E-047

Lower Axle Seat Weld Inspection and Repair for Meritor RideSentry™ MPA Series Sliding Tandem Trailer Air Suspension Systems

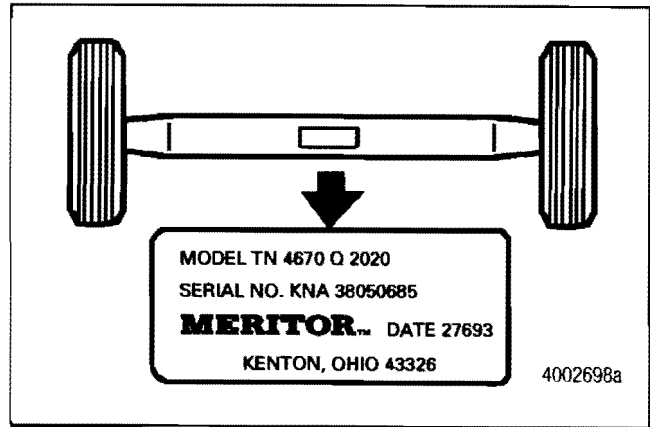
Figure 3

- Complete 17-digit vehicle identification number (VIN)
- ArvinMeritor axle model and serial number. Figure 3.
- Vehicle owner's name, address and telephone number
- Vehicle in-service date
- Repair facility's name, address and telephone number
- Repair facility's hourly rate
