TO: All Mazda Dealership General Managers, Service Managers, and Parts Managers
DATE: March 2010
SUBJECT: 2010 CX-9 Seat Warmer Voluntary Safety Recall 5810B

ATTACHMENT I - DEALER INFORMATION
Safety Recall 5810B

2010 CX-9 - SEAT WARMER VOLUNTARY SAFETY RECALL 5810B

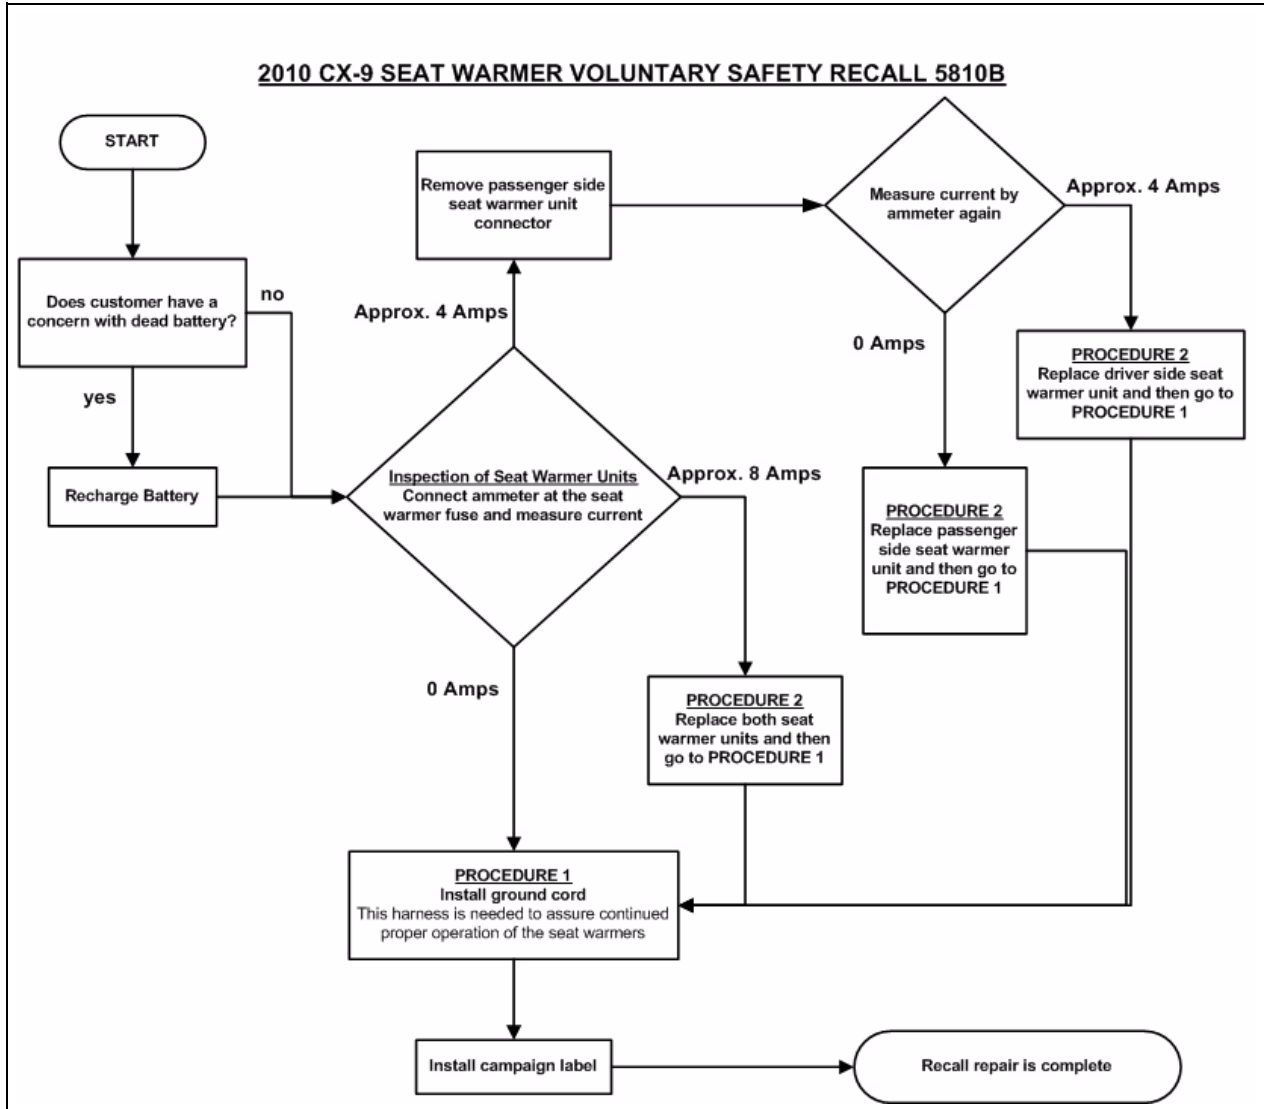
D. REPAIR FLOW CHART

This is an overview of the repair. Refer to section “E. REPAIR PROCEDURE” for details.

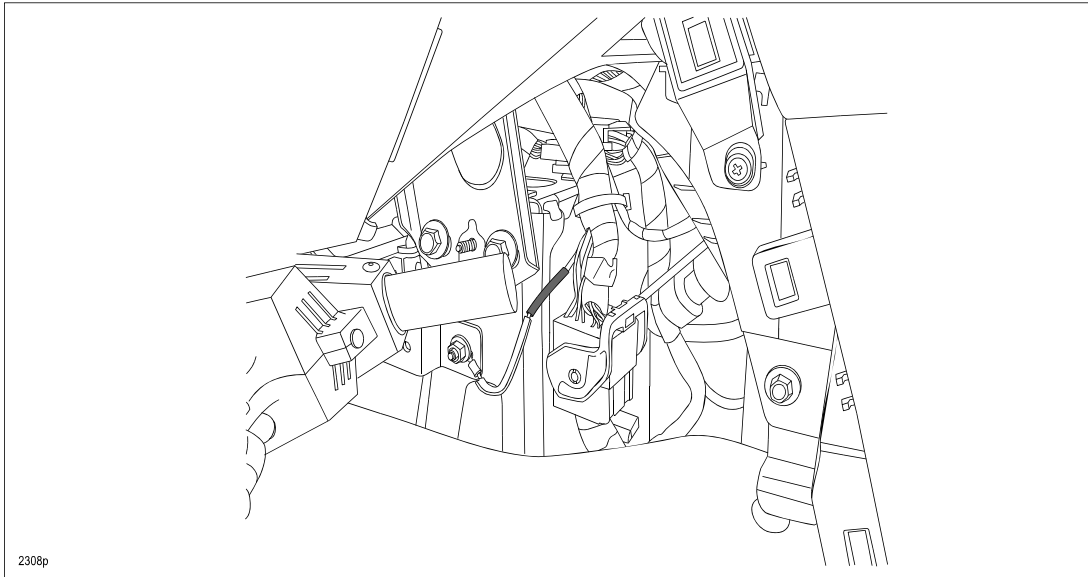
<p>CORRECTLY MELTED HEAT SHRINK TUBING USING FLAMELESS HEAT GUN</p> <ul style="list-style-type: none">• Tubing melted smooth across entire length.	<p>INADEQUATELY MELTED HEATED SHRINK TUBING</p> <ul style="list-style-type: none">• Tubing charred from overheating.• Ends not fully melted.

22. Position heat shrink tube over the butt connector. Using heater-drier, apply heated air until tubing shrinks securely.

NOTE: When using heater-drier, be careful not to heat trim panels.
