# Technical Bulletin

Section Title: Body, Cab and Accessories  
TSB No. TS 00 08100R

**SUBJECT:** SAFETY RECALL CAMPAIGN: SG, COUNTERMEASURE OF INSTRUMENT PANEL CENTER LOWER BOX.  
**MODEL(S):** KIZASHI (A6B424)  
**YEAR:** 2010 (BUILT BETWEEN OCTOBER 13, 2009 TO JUNE 17, 2010)

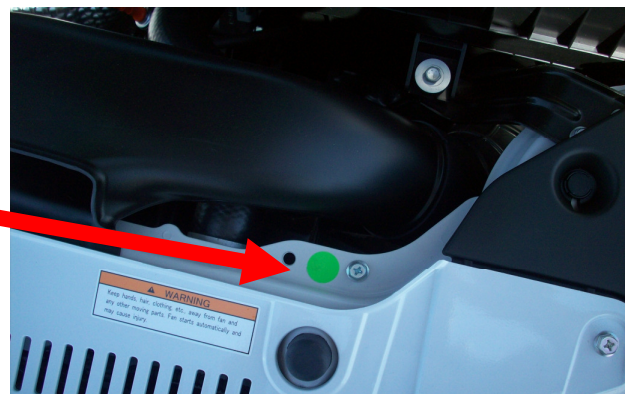
**Note:** Vehicles that had the campaign performed before leaving the port should have a “Green” label on the radiator support as shown. If there is a label similar to the one shown to the right, do not continue, no further action is required.

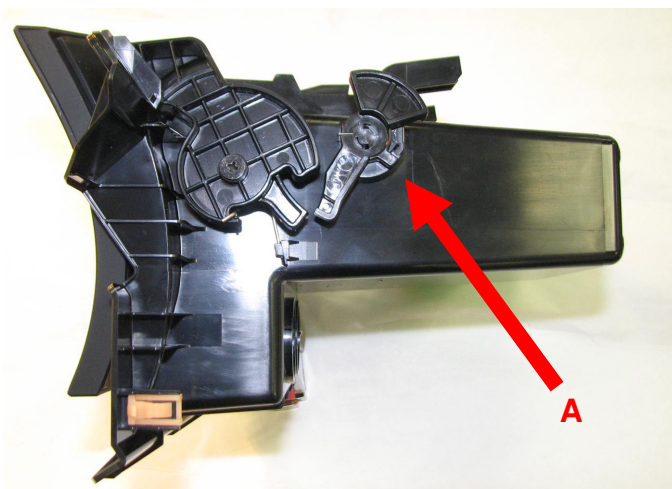
When you remove the instrument panel center lower box, if you find that it is identical to the new countermeasure part “B”, examples of both are shown below, reinstall box, no further action required.

Part prior to countermeasure

A. With counter lock lever and flat, rectangular contact pad.
