Subject: Safety Recall A0M – Rubber Seal (Brake Master Cylinder Cup)
Certain 2005 through 2006 Model Year Toyota Avalon Vehicles &
Certain 2004 through 2006 Model Year Highlander (Non Hybrid) Vehicles

TECHNICAL INSTRUCTIONS
FOR
SAFETY RECALL A0M
RUBBER SEAL (BRAKE MASTER CYLINDER CUP) REPLACEMENT
2004 – 2006 MODEL YEAR HIGHLANDER
2005 – 2006 MODEL YEAR AVALON

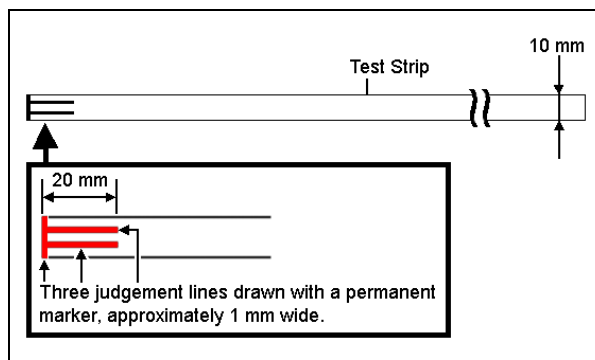
D. SECONDARY INSPECTION FOR BRAKE FLUID LEAKAGE

<p>Rod Retainer</p> <p>Spring</p> <p>Fluid droplet on rod retainer</p> <p>Fluid droplet on spring</p>	<p>Booster requires additional inspection</p> <p>Proceed to section D "SECONDARY INSPECTION FOR BRAKE FLUID LEAKAGE"</p>
