Subject: Safety Recall A0P – **Remedy Notification**
Certain 2011 Model Year Sienna Vehicles Brake Light (Stop Lamp) Switch Bracket

TECHNICAL INSTRUCTIONS

SAFETY RECALL A0P

BRAKE LIGHT (STOP LAMP) SWITCH BRACKET REPLACEMENT

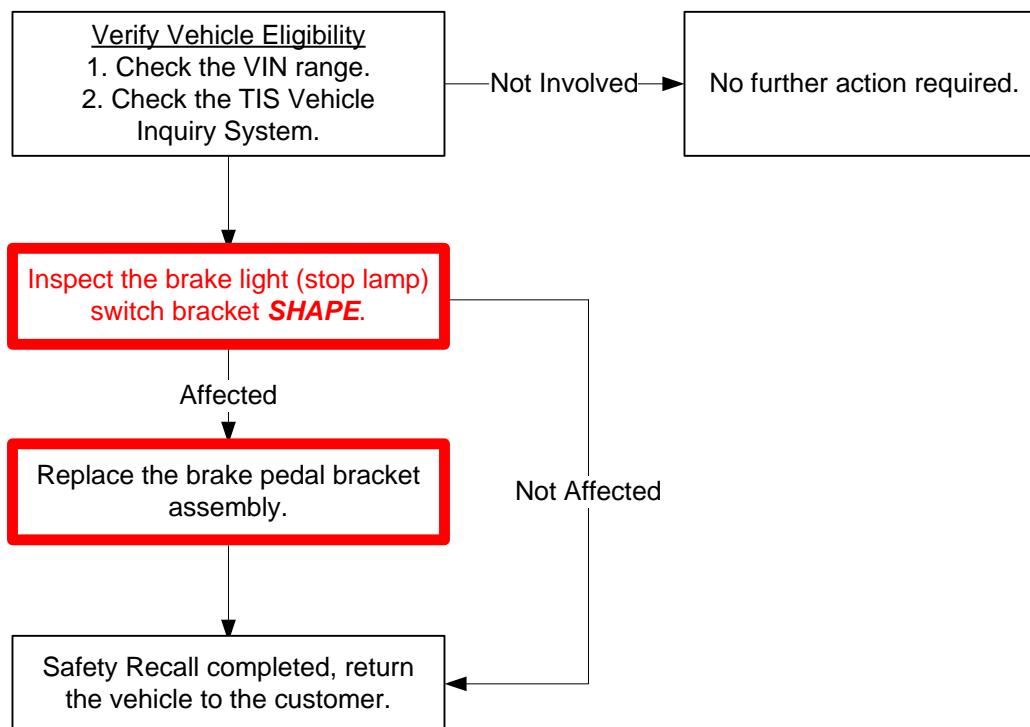
2011 Model Year Sienna

Prior to your appointment, please be aware of the close proximity of the stop lamp switch bracket to the parking brake pedal, shown in the diagram below. You may minimize the possibility of this condition occurring until the remedy is performed by assuring the bracket is not bent. We apologize for any inconvenience created by this condition.

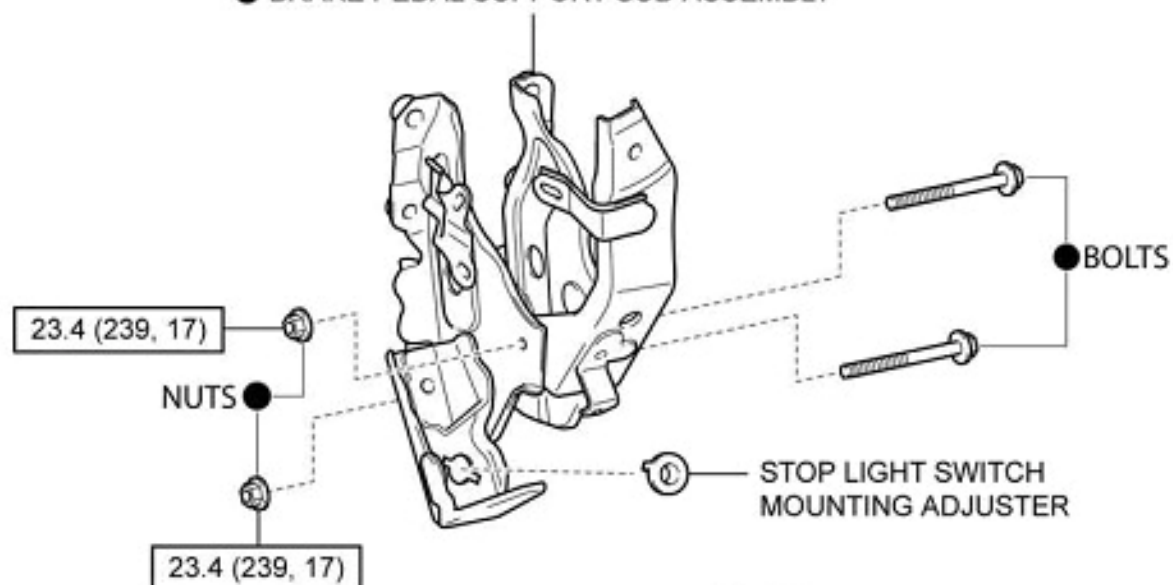
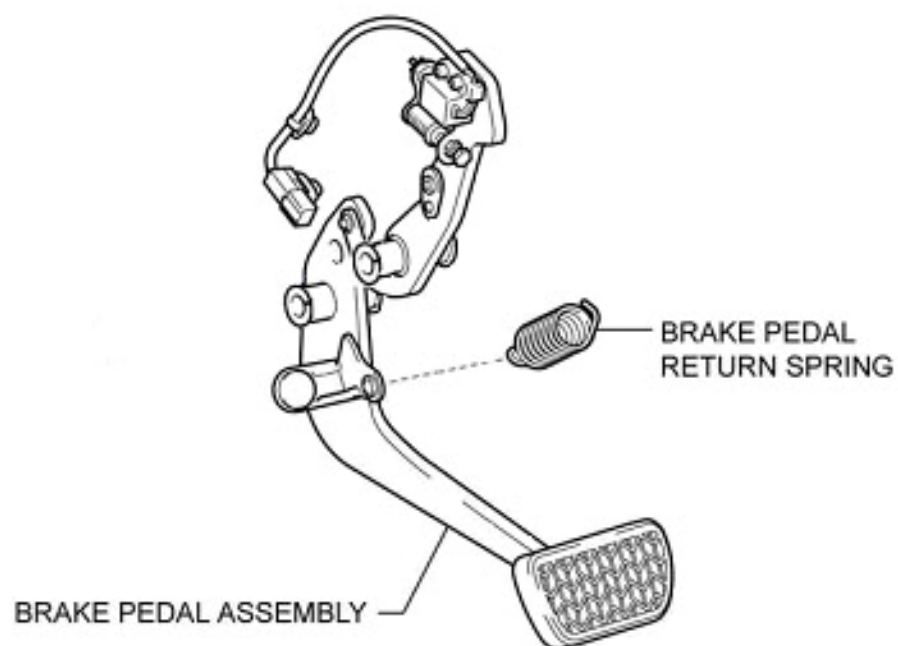
● BRAKE PEDAL SUPPORT SUB-ASSEMBLY

The stop lamp switch is mounted on a small bracket welded on the left side of the brake pedal support assembly. The bracket is relatively close to the parking brake pedal when the parking brake is fully applied. Due to its proximity to the parking brake pedal, in limited circumstances the stop lamp switch bracket could be deformed (bent) by the driver's foot during parking brake application. Depending on the amount of bracket deformation, this condition could result in the stop lamp switch engaging and causing the brake lights to remain on. If the deformation is significant, the service brake could become partially engaged due to contact from the bracket, resulting in brake drag with associated brake noise, vibration, and/or illumination of the brake warning light. If the driver does not notice these conditions and continues to drive the vehicle, braking effectiveness could be reduced.

- b) If the bracket shape is as shown continue to ***STEP B*** (Replace the bracket assembly).
