**R10RW**

# Incorrect Power Cable Lug Orientation

# RECALL

Models Affected: 2004 through 2009 Vision

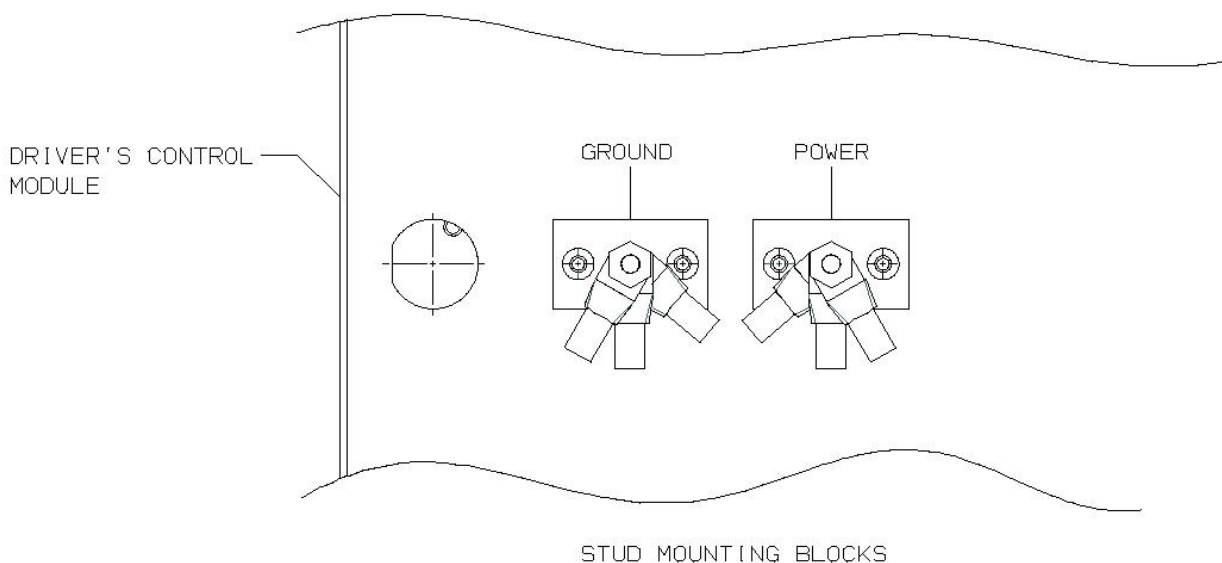
1. Park the vehicle on a level surface, apply parking brake, turn engine off, remove ignition key and chock wheels.
2. Disconnect batteries. *Always remove negative cables first.*
3. Open engine hood and locate the Chassis Power Stud(s) on the driver's side of the **Driver's Control Module (DCM)**. Depending on the type of engine installed and options on the vehicle (air conditioning and/or lift), there could be one or two power studs next to the Ground Stud. See the following diagrams.

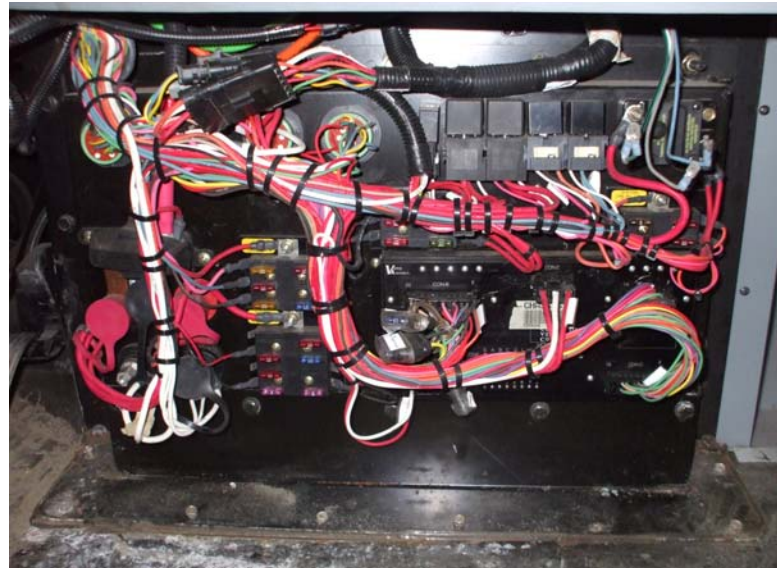
- b. Remove the fasteners securing the PDU to the Driver's Control Module (DCM) and the fasteners securing the PDU to the floor.
