# RECALL CAMPAIGN BULLETIN

NTB10-071a

## VOLUNTARY SAFETY RECALL CAMPAIGN EQUIPMENT / SERVICE PARTS SUSPENSION LOWER LINK

**CAMPAIGN ID #:** PC049  
**NHTSA #** 10E-019  
**APPLIED VEHICLES:** 2004 - 2010 Armada (TA60)  
2004 - 2010 Titan (A60)  
2005 - 2010 Frontier (D40)  
2005 - 2010 Pathfinder (R51)  
2005 - 2010 Xterra (N50)

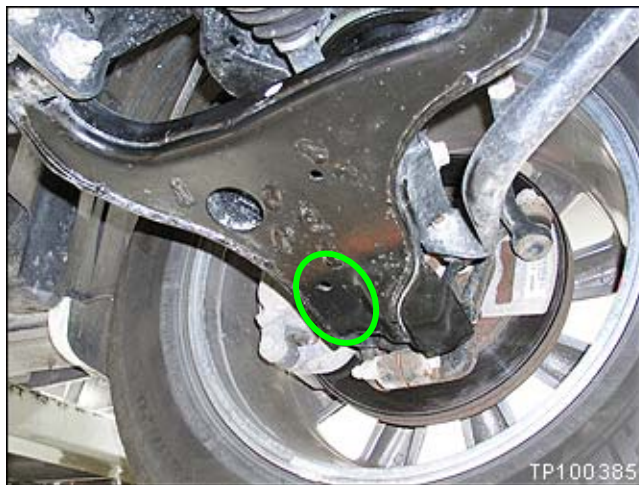
Front: Armada and Titan

1. Raise the vehicle.
2. Locate and write down the “Lot Number” stamped on the bottom side of the suspension lower links.
  - Refer to the Lot Number Locations below.
  - Armada and Pathfinder: Inspect front and rear (all 4) lower links.
  - Frontier, Titan, and Xterra: Inspect both front lower links.
3. Compare the Lot Number of each lower link to the Lot Number examples on the next page.

- **First two positions match one of the above: NG, replace only that link**
  - Compare the Lot Number from each link.
  - Replace **only** the link(s) with a match to one or the examples above.
- **No match to the examples above: OK, do not replace link**
  - Compare the Lot Number from each link.
  - Do not replace link if there is not a match to one of the examples above.
- **All links check OK: No further action needed.**
