# RECALL CAMPAIGN BULLETIN

NTB10-071

June 23, 2010

## VOLUNTARY SAFETY RECALL CAMPAIGN EQUIPMENT / SERVICE PARTS SUSPENSION LOWER LINK

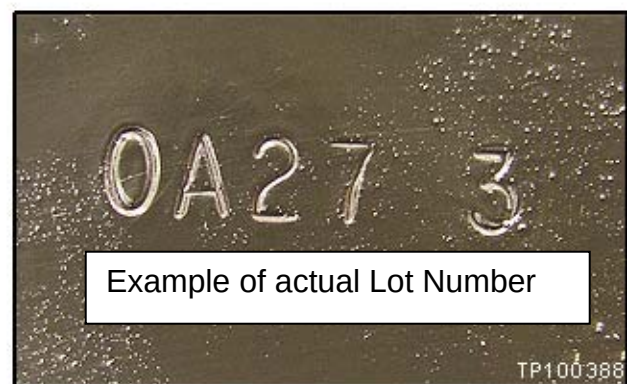
Lot Number Examples:

Compare the Lot Number of each lower link to these Lot Number examples.

- **Z, Y, or A is one of the first three: NG, replace only that link**
  - Compare the Lot Number from each link.
  - Replace **only** the link(s) with Z, Y, or A in one of the first three positions.
- **Not readable or missing Lot Number: NG, replace only that link**
  - Compare the Lot Number from each link.
  - Replace link if the Lot Number is not readable or missing.
- **Z, Y, or A is not one of the first three: OK, do not replace link**
  - Compare the Lot Number from each link.
  - Do not replace link if Z, Y, or A is not one of the first three positions.
- **All links check OK: No further action needed.**
