# RECALL CAMPAIGN BULLETIN

NTB10-037

## VOLUNTARY SAFETY RECALL CAMPAIGN 2005 – 2009 ARMADA AND TITAN FUEL GAUGE INACCURACY

**CAMPAIGN ID #:** R1010  
**NHTSA #:** 10V-074  
**APPLIED VEHICLES:** 2005 – 2009 Armada (TA60)  
2005 – 2009 Titan (A60)

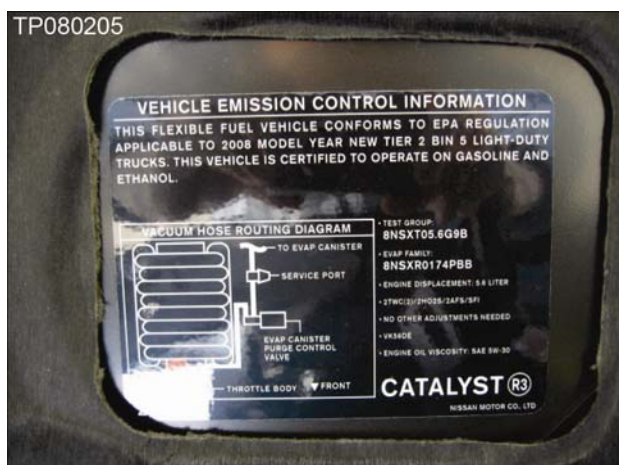
Figure A: FFV Label under the hood

\* Flexible fuel vehicles can be identified by looking at the under-hood emission label or the fuel filler door label (see Figures A and B below).
