**TECHNICAL INSTRUCTIONS  
FOR  
SAFETY RECALL A0G  
SKID CONTROL ECU CALIBRATION UPDATE  
2003 MODEL YEAR SEQUOIA**

***UPDATED April 28, 2021***

On certain 2003 Model Year Toyota Sequoia vehicles, the center position of the Steering Angle Sensor (SAS) may not be stored correctly due to improper logic of the Skid Control ECU programming. If this occurs, in most cases the VSC/TRAC warning light will illuminate. However, in limited situations the Vehicle Stability Control (VSC) system could activate at low speed (approximately 9 mph) for a few seconds after acceleration from a stopped position, and the vehicle may not accelerate as quickly as the driver expects.

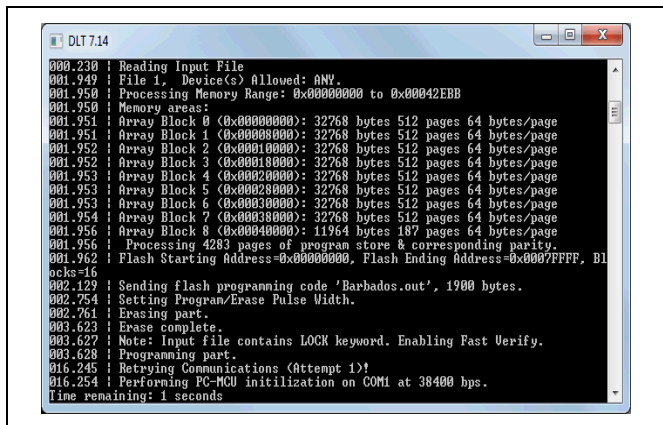
### Error Code 2021: Forced error by turn IGN Off

Poor AOG cable connection  
IGN turned off during reprogramming

Error forced: turn OFF IGN while download APL: -> DLT will make a retry to reconnect to ECU (Attempt 1-3)

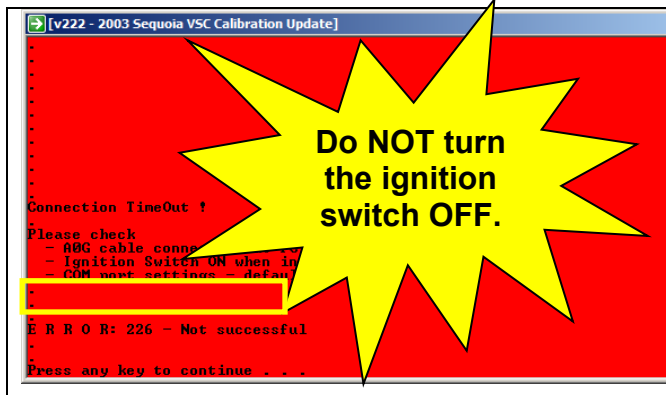
## Error Code: 28677: DLT not successful

Communication error (IGN turned off during reprogramming)

If you received a red error screen note the Return/Error Code and proceed to the next page to perform the VSC Failure Recovery.
