File In Section: Product Recalls  
Bulletin No.: 10153A  
Date: July 2010

# Recall Bulletin

**SUBJECT:** Heated Windshield Washer Module Short Circuit – Permanently Disable and Remove Module

**MODELS:** 2006-2009 Buick Lucerne  
2008-2009 Buick Enclave  
2006-2009 Cadillac DTS  
2007-2009 Cadillac Escalade, Escalade ESV, Escalade EXT  
2008-2009 Cadillac CTS  
2007-2009 Chevrolet Avalanche, Silverado, Suburban, Tahoe  
2009 Chevrolet Traverse  
2007-2009 GMC Acadia, Sierra, Yukon, Yukon XL  
2006-2009 HUMMER H2  
2007-2009 Saturn OUTLOOK  
Equipped with Heated Washer Fluid System (RPO XA7/CHW)

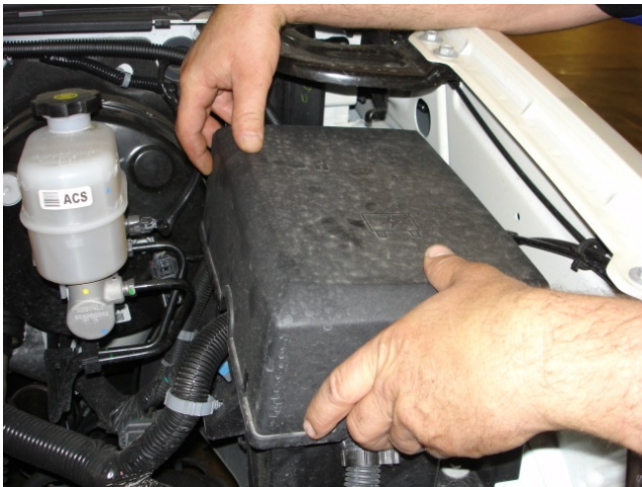
2182449

2. Locate the underhood bussed electrical center (UBEC).

3. Remove the UBEC cover and locate the 60 amp heated windshield washer fuse.

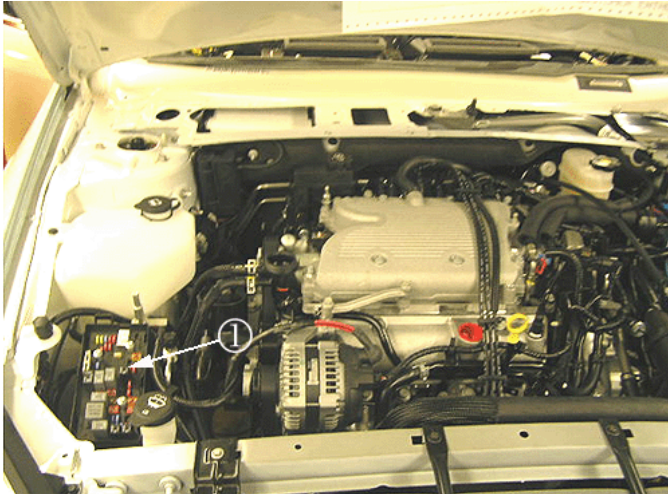
2182457

2. Locate the underhood bussed electrical center (UBEC) (1).

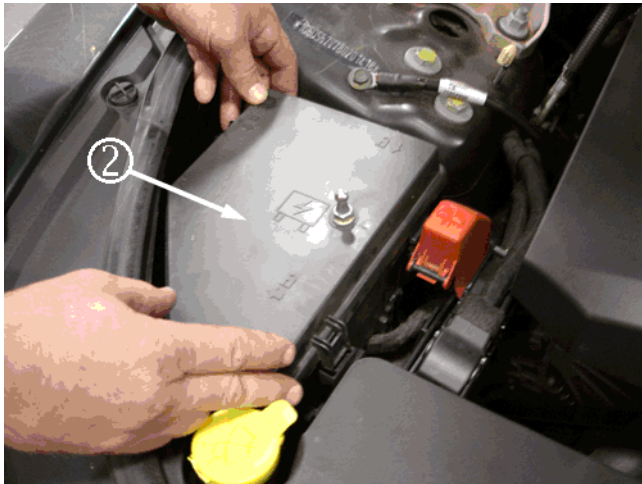
2476560

3. Locate the underhood bussed electrical center (UBEC) (2).
4. Remove the UBEC cover (2) and locate the WSW/HTR 60 amp heated windshield washer fuse.

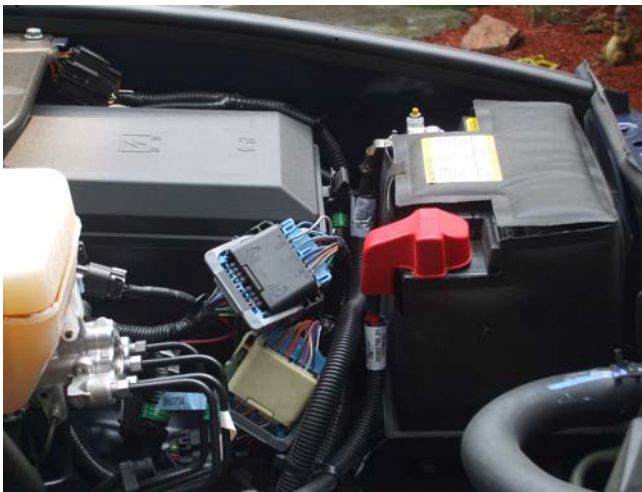
2182546

2. Locate the under-hood bussed electrical center (UBEC).
3. Remove the UBEC cover and locate the 60 amp heated windshield washer Mega fuse.

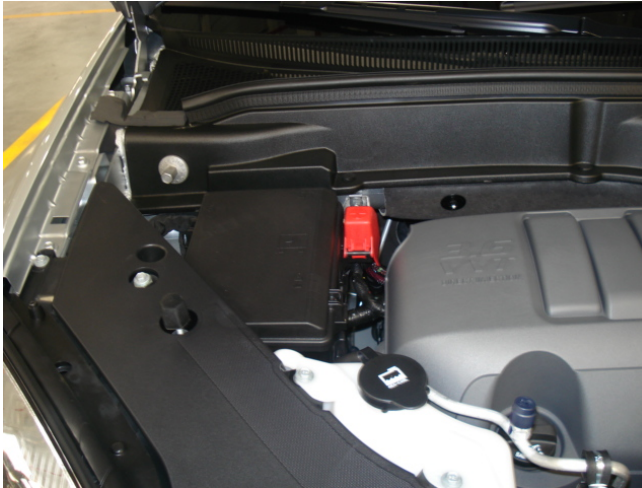
2182446

2. Locate the underhood bussed electrical center (UBEC).
