# Safety Recall Circular

Code: **97S8**

**Subject: 2009 Routan  
Power Sliding Door Wiring Harness Assembly**

**October 18, 2010**

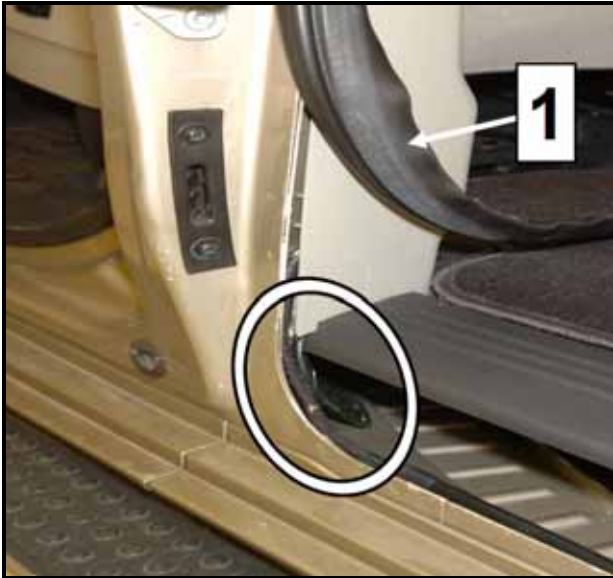
⇐ Inspect drive motor wiring harness -A- and door track wiring harness -B- for a wire chafe condition -circle-

Tip: Wire chafe condition -circle- is only an example

Wire chafe conditions may differ in appearance and may be present on either one or both harnesses

- ⇐ Inspect chain link track -arrow 1- for broken links, damaged wires, or the chain link track being disconnected from lower hinge bracket -arrow 2-
  - If there is no damage to either wiring harness or the chain link track, **go to Section C**
  - If no more than two wires are damaged on the power sliding door wiring harness and/or if up to four wires are damaged on the drive motor wiring harness, **go to Section D** for wiring repairs
  - If chain link track is disconnected or damaged, and/or more than two wires on the power sliding door wiring harness(es) are damaged, **go to Section B** to replace the harness(es)
