Safety Recall Circular

Code: **97S8**

**Subject: 2009 Routan
Power Sliding Door Wiring Harness Assembly**

October 20, 2010

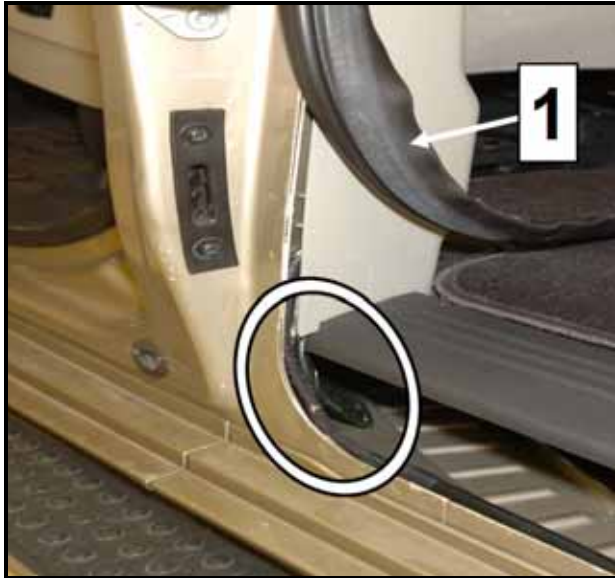
Section A – Inspect Chain Link Track and Wiring Harnesses

⇐ Inspect drive motor wiring harness -A- and door track wiring harness -B- for a wire chafe condition -circle-

Tip: Wire chafe condition -circle- is only an example

Wire chafe conditions may differ in appearance and may be present on either one or both harnesses

- ⇐ Inspect chain link track -arrow 1- for broken links, damaged wires, or the chain link track being disconnected from lower hinge bracket -arrow 2-
 - If there is no damage to either wiring harness or the chain link track, **go to Section C**
 - If no more than two wires are damaged on the power sliding door wiring harness and/or if up to four wires are damaged on the drive motor wiring harness, **go to Section D** for wiring repairs
 - If chain link track is disconnected or damaged, and/or more than two wires on the power sliding door wiring harness(es) are damaged, **go to Section B** to replace the harness(es)

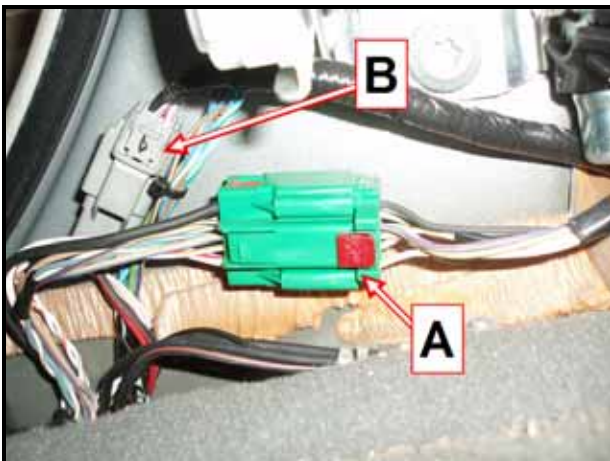
- Disconnect affected chaffed wiring harness connector from main wiring harness connector at lower B-pillar
- ⇐ If power sliding door harness -A- requires repair, continue with procedure
- ⇐ If drive motor wiring harness -B- requires repair, note method used to tape the convolute, and then remove electrical tape from convolute. Slide wires through split in convolute to expose chaffed wire(s), then continue work procedure
