PROCEDURE

Modify the sound insulation on both the left-hand side and right-hand side as outlined below:

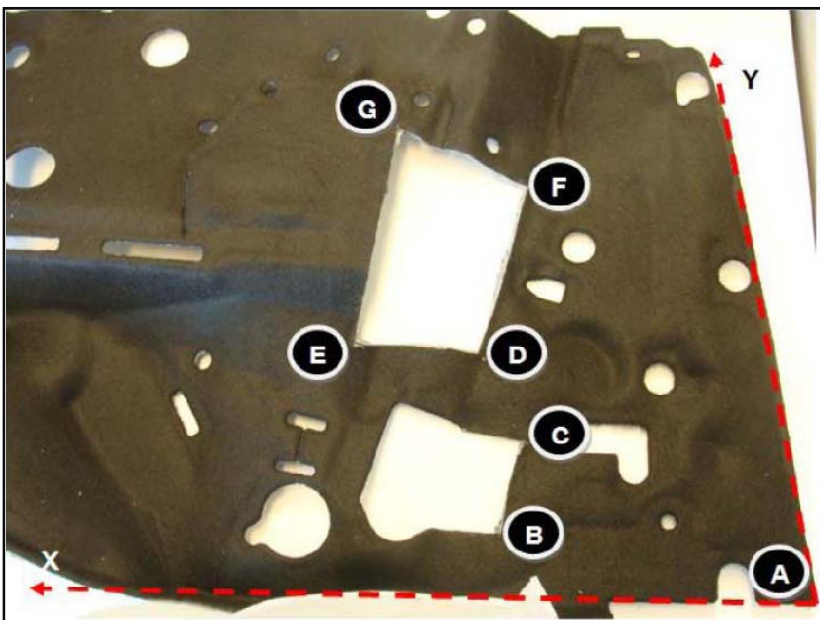
- The Driver's side insulation is shown. Modify the sound Insulation for the passenger's side "mirror-image"

- Reinstall the modified sound insulation on the left and right quarter panels.
