PRODUCT CAMPAIGN BULLETIN

APPLICABILITY: 2010MY Subaru Legacy & Outback
SUBJECT: Steering Column Electrical
 Roll Connector

NUMBER: WVR-28
DATE: June 2010

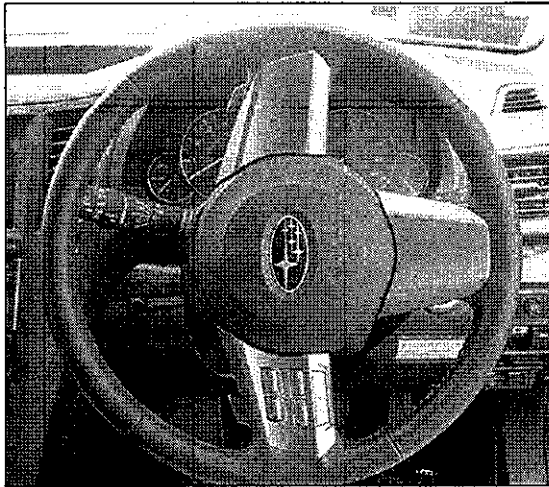
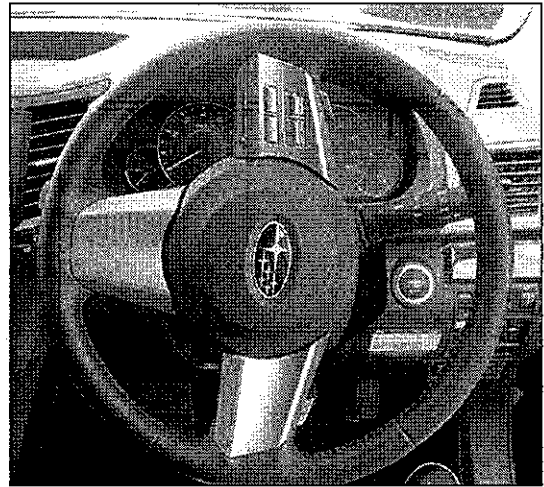
- 1) Start the engine and rotate the steering wheel 90 degrees from a straight-ahead position (either left or right rotation). Turn the ignition switch to the OFF position

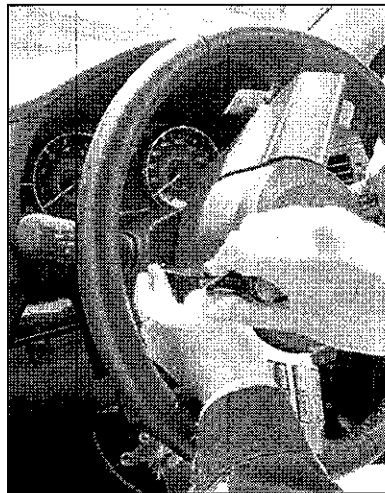
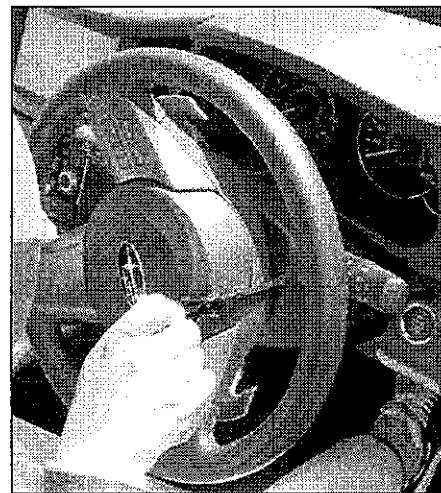
- 2) Adjust the tilt position to the lowest position and lock the tilt lever. Remove the upper steering column cover screw on one side, rotate the steering wheel 90 degrees and remove the screw on the other side.

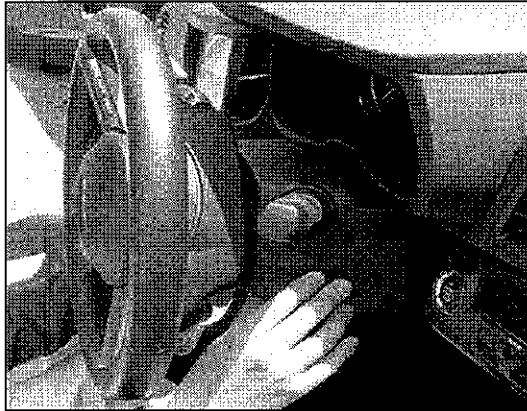
3) Release the claws and detach the steering column lower cover.

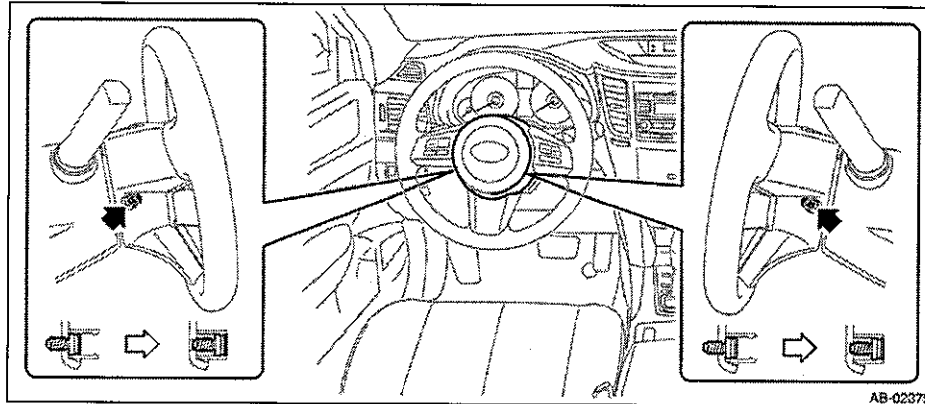
- 1) Position the front wheels straight ahead. (After moving vehicle 5 m (16 ft) or more with front wheels positioned straight ahead, make sure that the vehicle moves straight ahead).
- 2) Record preset radio stations
- 3) Turn the ignition switch to OFF.
- 4) Disconnect the ground cable from the battery and wait at least 60 seconds before proceeding.
- 5) Remove the driver's airbag module assembly. A TORX® T40 is required. Loosen the two TORX® bolts on the sides of the steering wheel.

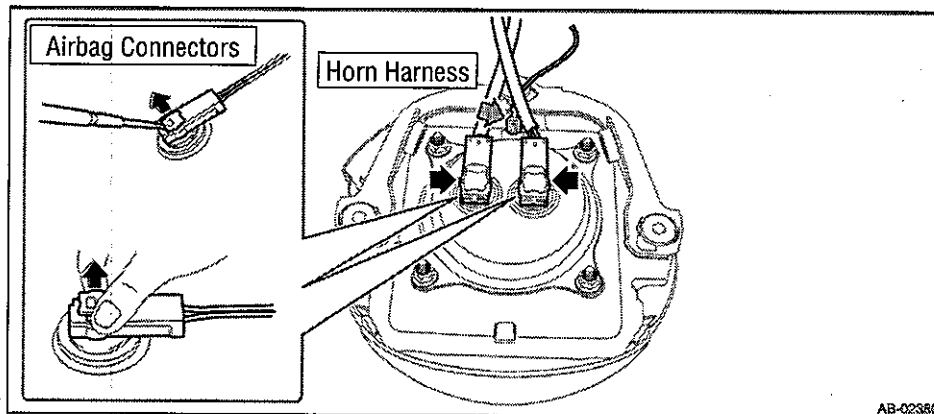
- 6) Disconnect the airbag connector and remove the airbag module assembly as follows:
 - a) Using a flat tip screwdriver, pry the push lock upward to unlock. Pull the connector to disconnect it from the driver's airbag module assembly.
 - b) Disconnect the Horn Harness.

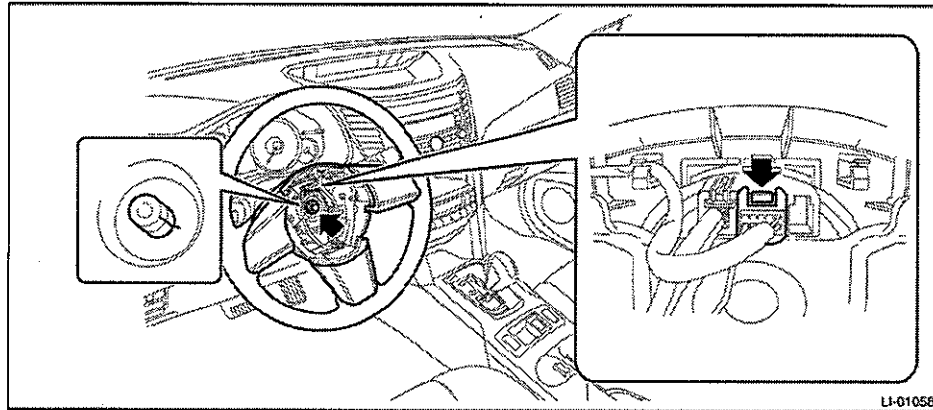
- a) Disconnect the wire harness connector and remove the steering wheel nut.
- b) Make alignment marks on steering shaft and steering wheel and remove the steering wheel.

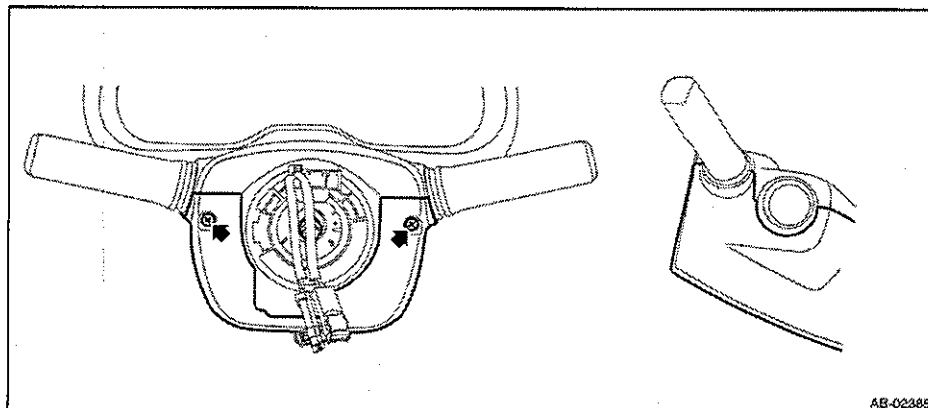
- a) Lower the lever of the steering column. Remove the steering column upper cover retaining screws, as shown.

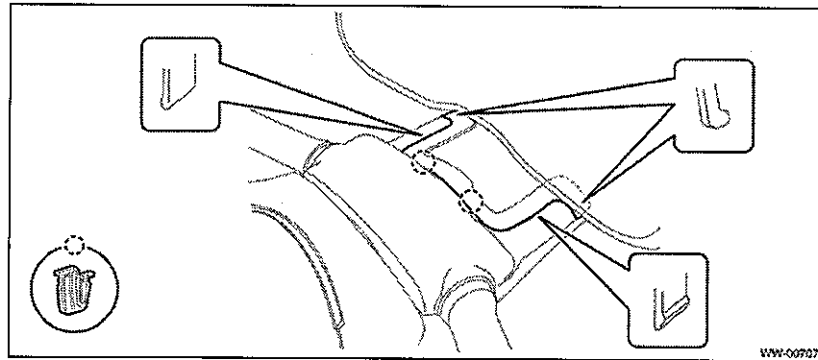
- b) Separate the steering column upper cover from the steering column top cover and remove.
