TRW Automotive  
Commercial Steering Systems

IGEN 3 Intermediate Shaft Weld Location  
Inspection Procedure

# TRW IGEN3 Intermediate Steering Shaft Assembly

# RECALL

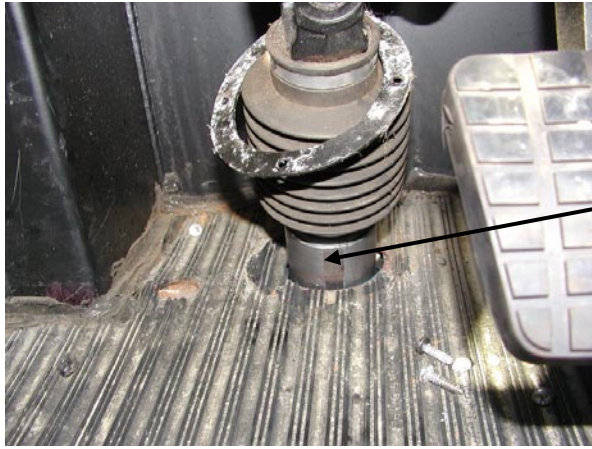
TRW Inspection Tool

- Record body number and four digit date code on sheet from Blue Bird provided with recall.
- If the date code does not fall within the range on TRW Service Procedure # COL-201, then no further action is required.
- If the date code falls within the range on TRW Service Procedure # COL-201, then remove the 4 Phillip head screws, slide trim ring up and remove shaft seal.
- Slide inspection tool around shaft and through the hole in floor.

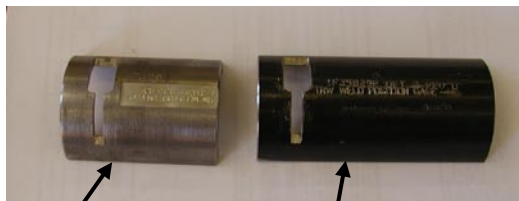
TRW Inspection Tools

- The window for the inspection will be visible from underneath driver's floor. Rotate the shaft by turning the steering wheel to inspect weld per TRW Service Procedure # COL-201. If the part passes, follow TRW Service Procedure # COL-201 and then mark the Blue Bird Sheet. If the part fails, mark the sheet and return to the Blue Bird Recall Administrator. **NOTE:** If the weld cannot be seen in the installed position, remove the shaft for inspection. New fasteners **MUST** be use to reinstall the shaft.

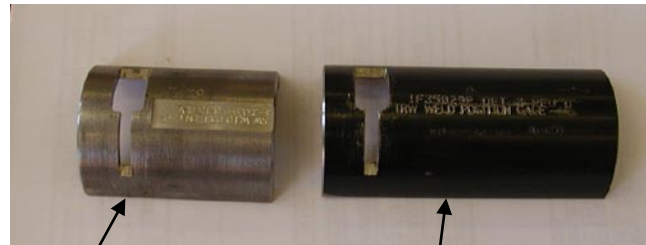
### TRW Inspection Tools

9. Rotate the shaft by turning the steering wheel to inspect weld per TRW Service Procedure # COL-201. If the part passes, follow TRW Service Procedure # COL-201 and then mark the Blue Bird Sheet. If the part fails, mark the sheet and contact Blue Bird Recall Administrator.
10. After the inspection process has been completed for both upper and lower shaft, remove jack stands, and reconnect batteries by connecting the negative last.
11. Place bus back in service.
