# Technical BULLETIN

## SAFETY RECALL

### 2009 VMX17Y/YC

### FACTORY MODIFICATION CAMPAIGN – APS/TPS Wiring

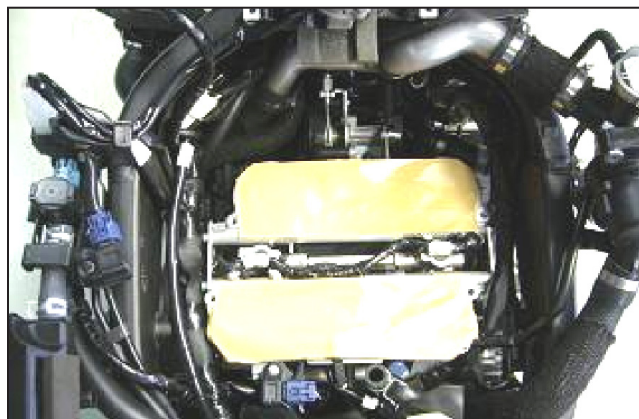
1. Set the engine stop switch to the stop position to prevent engine starting. Check the malfunction code history with the diagnostic system mode D:61. If there are any codes indicating a problem, repair that problem separately before beginning this modification.
2. Remove the parts listed below:
  - Rider seat
  - Meter assembly 2 cover
  - Top cover
  - Meter assembly 2
  - Main switch cover
  - Both intake duct assemblies
  - Battery leads from battery
  - ECU tray (Battery cover)
  - Air filter case (disconnect and remove with Intake funnel servo motor)

- Be sure to remove and retain the 4 lower air filter case gaskets so they will not be lost, as they will be reused.
- Cover the throttle body bore with tape to prevent foreign material from entering the engine.
