**SUBJECT: Suspension Inspection and Repair for
Broom Bear Sweepers mounted on
International 4300 Chassis**

DATE: 08/02/2010

NUMBER: SB-0078

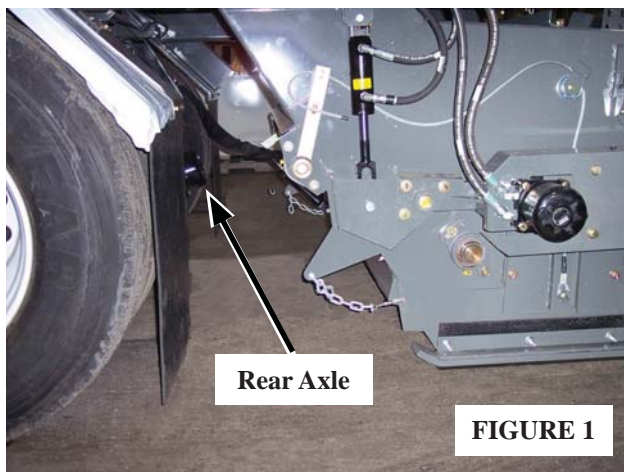
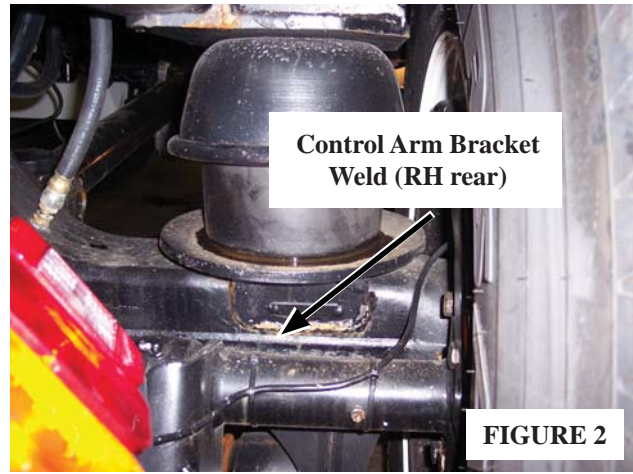
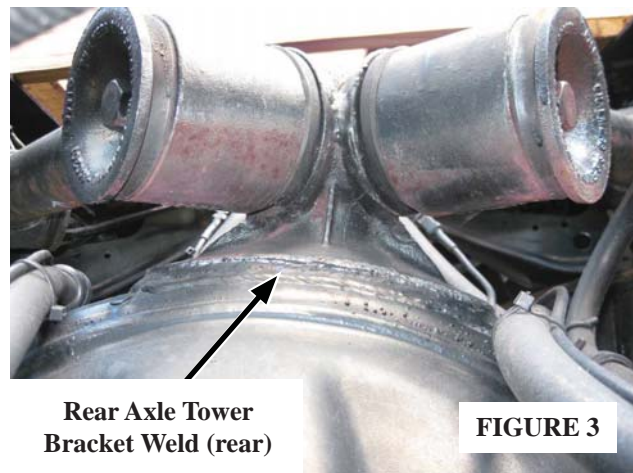
Inspect the welds for weld shape, lack of penetration, and cracks. If necessary, use a wire brush to clean the weld to get a better visual.

1. Visually inspect the front and rear weld attachment of the left and right suspension control arm brackets to the axle housing. (FIGURE 2 (RH is shown, LH is similar))

1. Grind out the old weld deposit before re-welding. Care should be taken to not grind too much from the surface of the axle housing, which could leave a thin wall for the re-weld.
2. Using a E7018 welding rod, re-weld the joint to the specifications shown in the attached "Chalmers Suspensions" drawing.
3. Clean and re-paint the weld area with suitable medium gloss black paint (obtain locally).

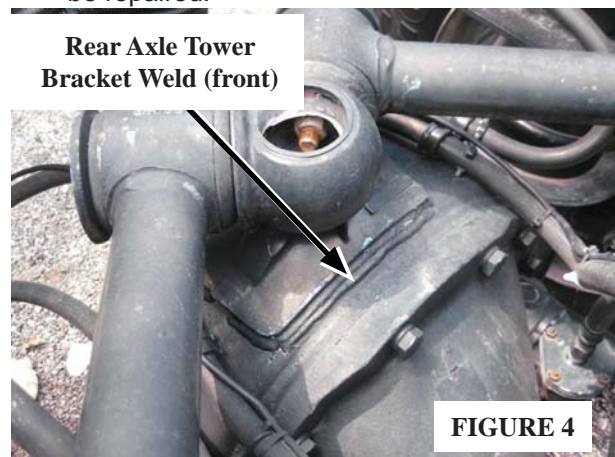
2. Visually inspect the front and rear weld attachment of the tower brackets to the center axle housing. (FIGURES 3 and 4)
3. Complete the checklist provided in the attached addendum.
4. Welds not meeting the inspection criteria must be repaired.

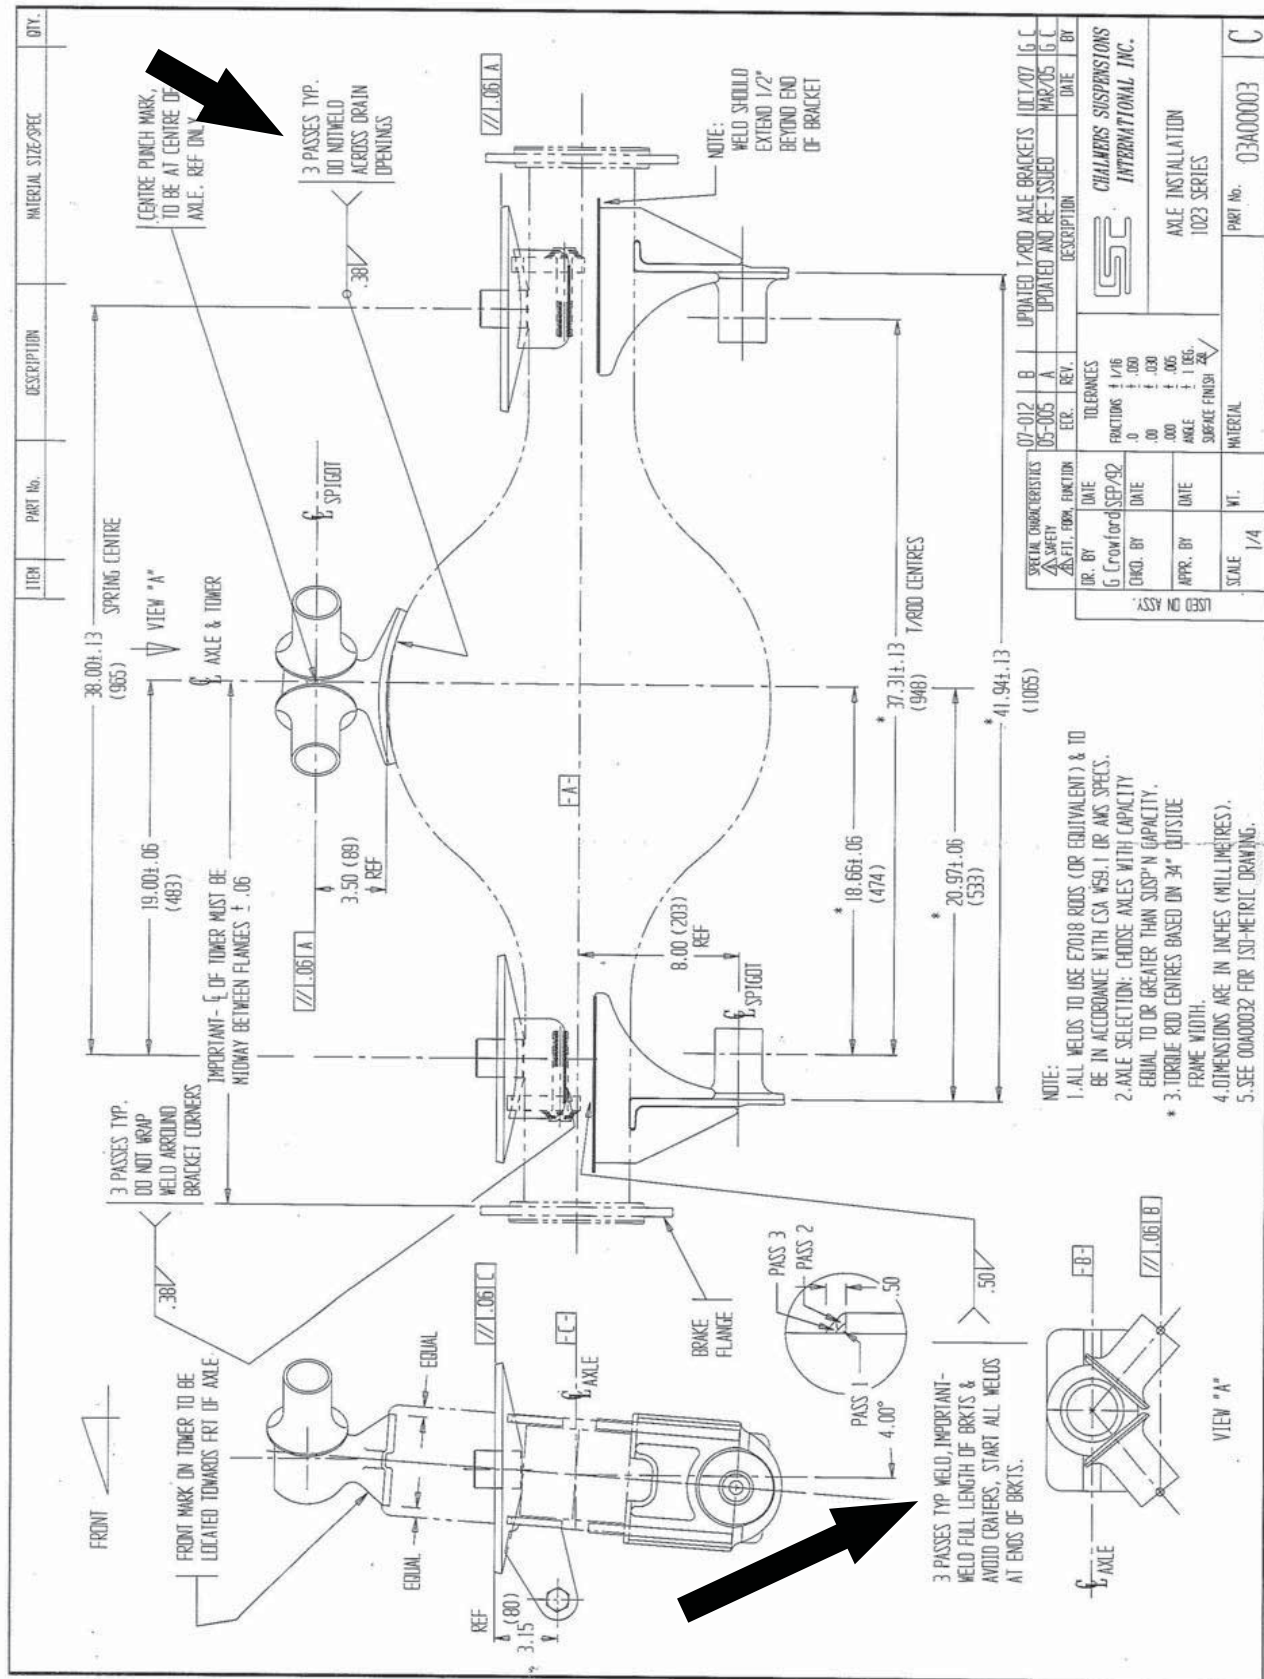
1. **Size** - Control Rod brackets should have 0.45" minimum weld height (total). Tower weld is also a 3 pass weld and should be 0.325" minimum.
2. **Appearance** - Inspect for weld shape, lack of penetration, and cracks. If necessary, use a wire brush to clean the weld to get a better visual.
3. If the weld is defective, all the old weld should be ground out prior to applying a new one. Care should be taken not to grind too much from the surface of the axle housing which could leave a thin wall for the re-weld.

Repair must be completed in compliance with the drawing supplied in this bulletin.
